- **Location:**
Midland, Michigan
- **Profile:**
Six-Story Building
- **Project:**
Masonry Restoration & Weatherproofing - North Hotel Tower

Acquest Realty Advisors, Inc. Ashman Court Hotel/Dow Corporation

Ashman Court Hotel is a six-story facility that was constructed with exterior brick masonry walls. This fairly new facility had experienced profuse

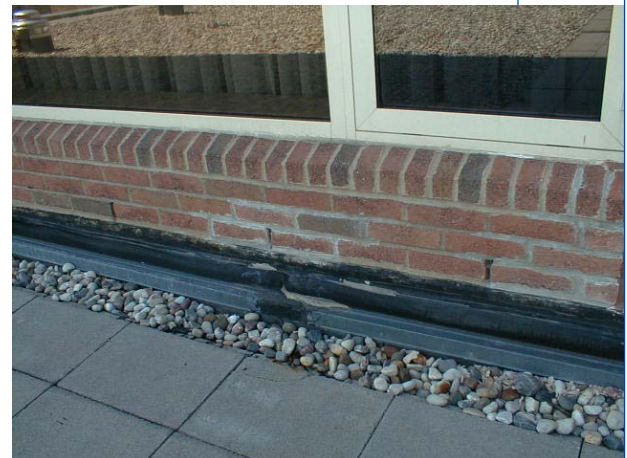
Water ingress caused by masonry distress and deficient through-wall flashings.

the North Tower wall. The first and second areas were both masonry flashing problems. There were significant deficiencies in the laps and transitions of the flashing, and in many areas the flashing was non-existent. The roof problem was discovered to be an expansion joint that did not allow for movement between deck transitions. Once the problems and causes were delineated, the construction specification was written and the project was bid out. The restoration process was now able to commence. For the wall problems, restoration included replacing damaged brick units, tuckpointing deficient mortar joints, and installing a new stainless steel through-wall flashing system for the exterior brick veneer. Exterior walls were cleaned to remove existing stains, and a clear water repellent sealer was applied to all exterior masonry sur-

Designed new stainless steel through-wall counterflashing

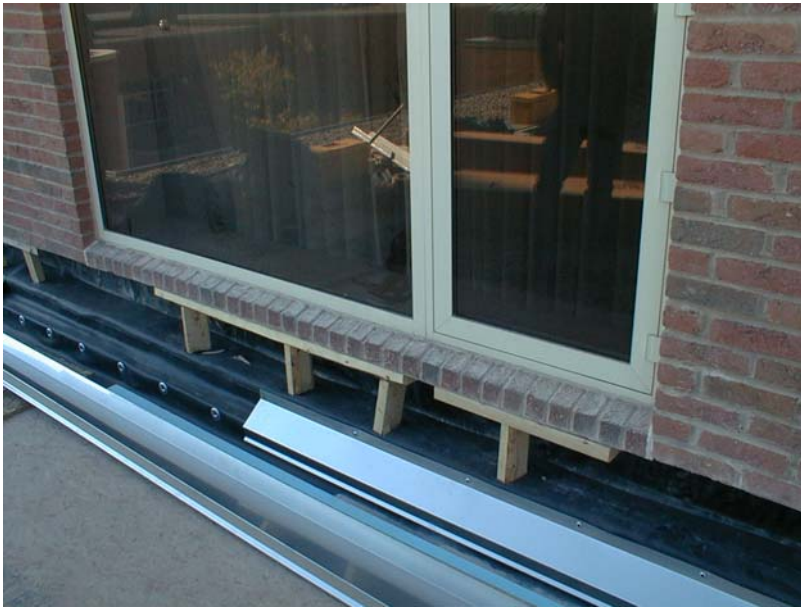
New through-wall flashings installed to correct the water ingress problem.

faces. Existing polyurethane elastomeric sealant was removed at all joints exhibiting open, deficient, or missing sealant and replaced with new elastomeric sealant materials. Corrective action for the roof involved remediation of an existing roof expansion joint detail and associated roof flashings along the base of the North Tower wall. These flashings were reconstructed with new EPDM materials and integrated with the masonry flashing system. Upon completion of the work, water testing was performed. Results from this testing showed that the specified exterior restoration and weatherproofing procedures were successful in correcting previous water leakage conditions inside the Ashman Court Hotel. ■
