- **Location:**
Midland, Michigan
- **Profile:**
Corporate Headquarters
- **Project:**
Exterior Penthouse Wall Remediation

CB Richard Ellis/Dow Corporation Dow Center/2040 Building

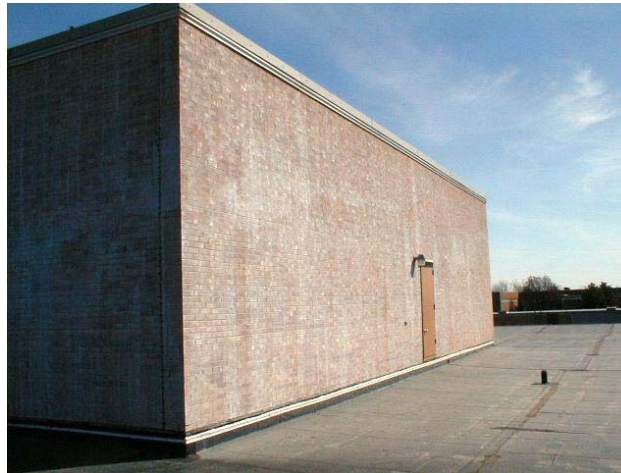
the problem or develop a remedy. StructureTec was then consulted and performed an evaluation of the exterior walls. StructureTec deduced that an incompatible sealer system had been applied to the masonry, creating this staining effect slowly over time. The condition was not efflorescence, as others had proposed, but was in fact staining due to a residue that had formed on the surface of the masonry. Although structural degradation had

Overview of staining on penthouse walls of Dow Center/Building 2040

problem could become structurally damaging as well as aesthetically displeasing. StructureTec analyzed the residue and then performed various tests in order to develop methods, means, and procedures for removing the residue without damaging the masonry surfaces in the process. Further tests were then performed to find a clear, water repellent sealer which would adequately weatherproof the walls without staining, while allowing for the breathability of the masonry. Recommendation procedures

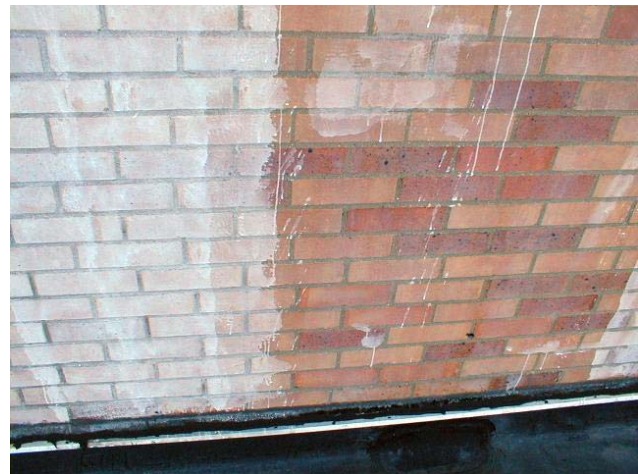
Methods, means, and procedures for removing the residue were tested on strips to determine effectiveness.

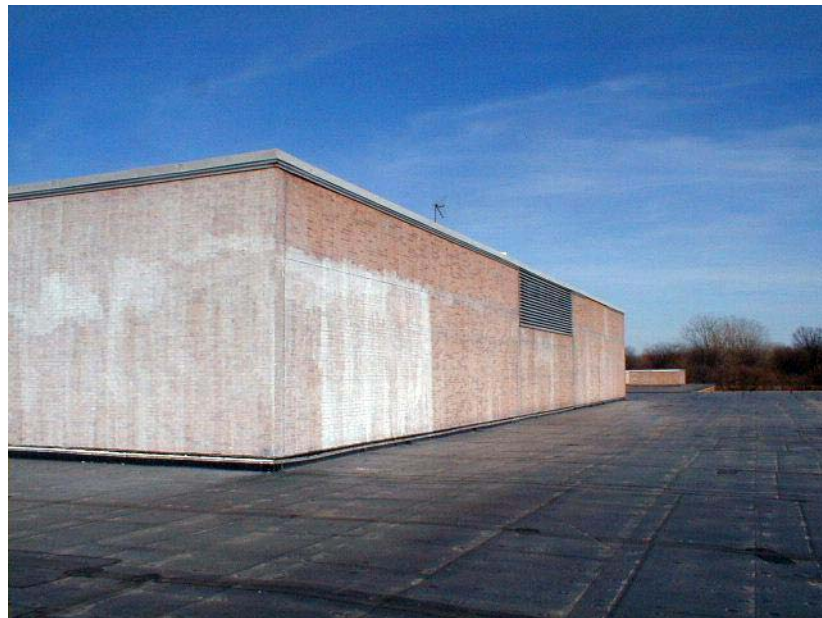
Residue staining was more severe on several areas of the walls.
