- **Location:**  
Adrian, Michigan
- **Profile:**  
150,000 sq. ft. of masonry
- **Project:**  
Restoration and Cleaning of Exterior Masonry Walls

## Christian Family Foundation Lenawee Christian School/ Christian Family Centre

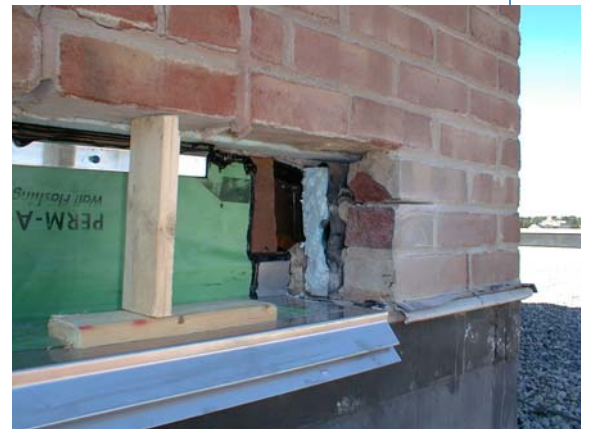
*New through-wall flashings consisting of stainless steel and a flexible waterproofing membrane were installed at upper wall levels.*

posite system consisting of a stainless steel pan and a flexible waterproofing membrane. All existing elastomeric sealant materials at exterior joints, wall penetrations, and window perimeters were removed and replaced with new silicone sealants. Exterior walls were cleaned to remove existing stains and a clear water repellent sealer was applied to all stone and brick masonry surfaces. Additionally, exterior concrete surfaces at mechanical wells were cleaned and weatherproofed with a new elastomeric breathable masonry coating. At ground-level, similar weatherproofing and restoration procedures were performed on

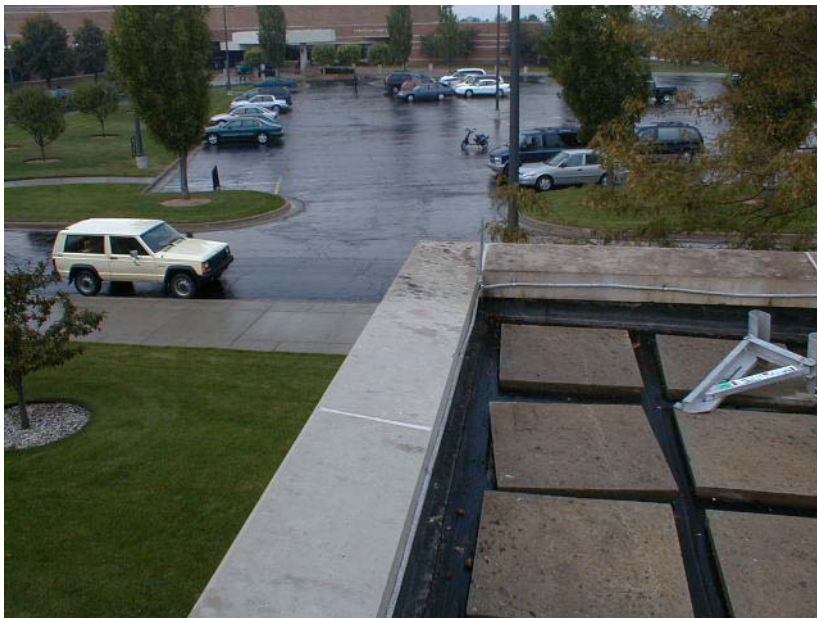
*Limestone units being cleaned and prepared for sealant/sealer applications.*
