- **Location:**
Toledo, Ohio
- **Profile:**
Multistory corrections facility
- **Project:**
Exterior Masonry and Below Grade Restoration

Restoration - Municipal

Lucas County, Ohio

Lucas County Corrections Center

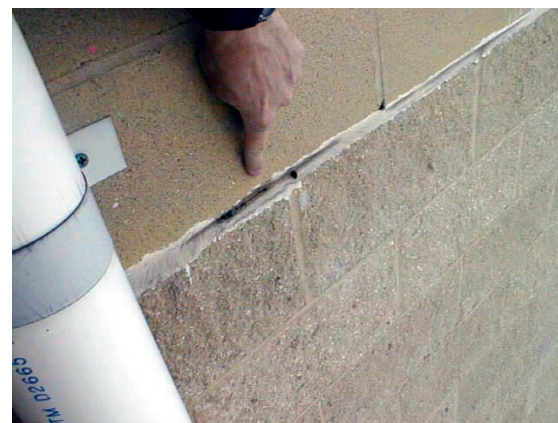
Previous sealant repairs had been performed at the joint between the standard masonry block and the split face masonry block. The weep holes have been plugged with sealant at various locations.

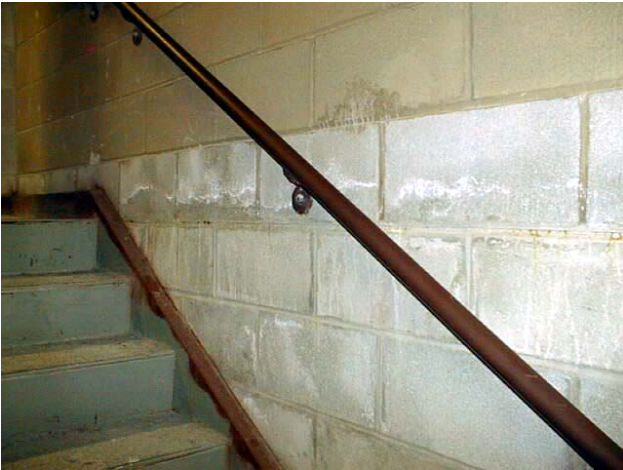
Moisture stains observed on the interior side of the masonry block wall located at the north stairwell.

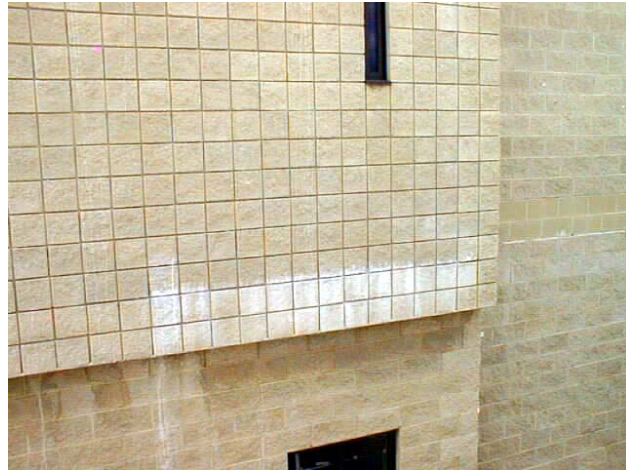
Efflorescence is observed due to moisture ingress into masonry wall, primarily concentrated near wall weep system.
