- **Location:**
Niles, Michigan
- **Profile:**
Multilevel Masonry Structure
- **Project:**
Restoration of Exterior Walls

Niles Community Schools Eastside Elementary School

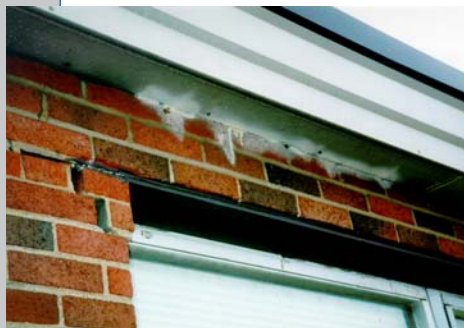
Window lintel and masonry degradation. Also, previous unsuccessful caulking.

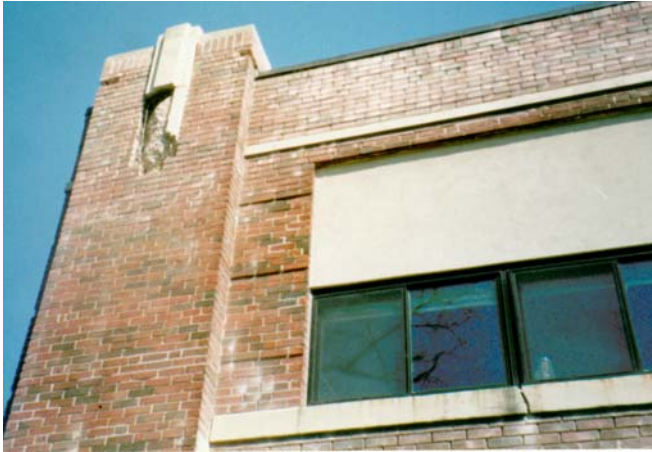
*Masonry mortar joints were deficient.
Concrete belt stone was cracking and spalling.*
