- **Location:**
South Bend, Indiana
- **Profile:**
256,000 sq. ft. facility
- **Project:**
StructureScan Survey

South Bend Community Schools *Washington High School*

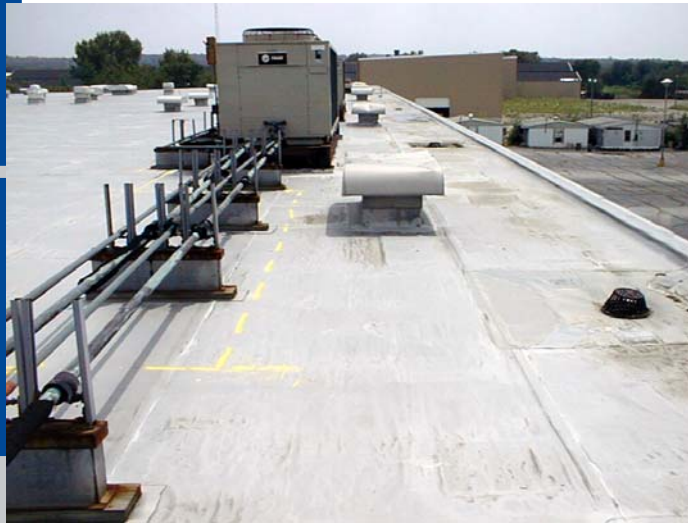
Overview of a field of roof

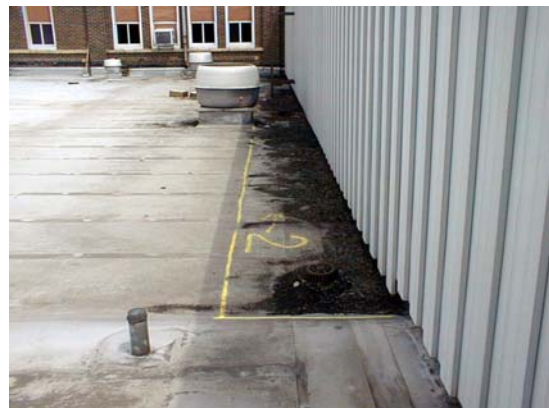
Areas of the roof with wet insulation were later repaired to extend the roof service life.

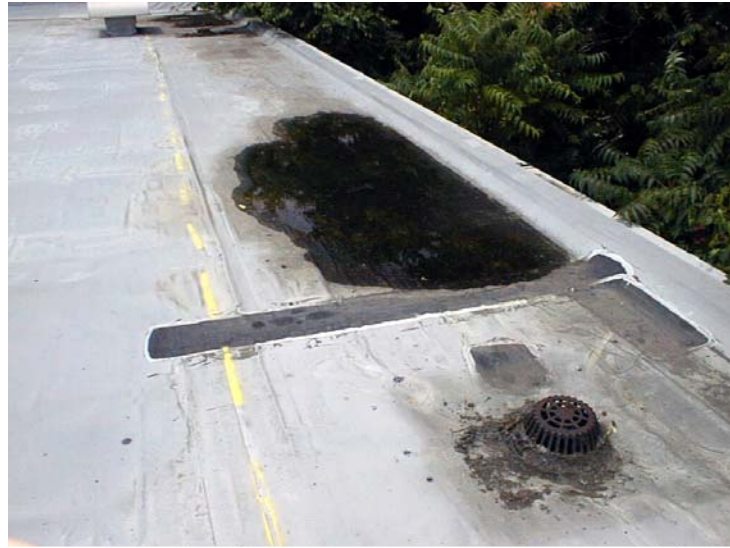
Splits and fractures in the membrane had been repaired previously without removing wet insulation beneath.

membrane. Foam-glass insulation has a closed cell structure which is supposed to be water-resistant. However, the in-place materials had broken down over time and water was able to enter the insulation. The overall roof configuration, however, was the reason for the weakness of the anomalies. Proper understanding of all of these factors allowed a very accurate analysis of the wet substrata. Detailed outlines were painted on the roof, depicting the apparent areas of wet. Once the analysis was complete, SBCS was able to implement the proper repairs. In conclusion, SBCS was able to extend the life span of their roof by addressing the specific areas of concern and the causes of the problems, allowing for the maximum return on investment. ■

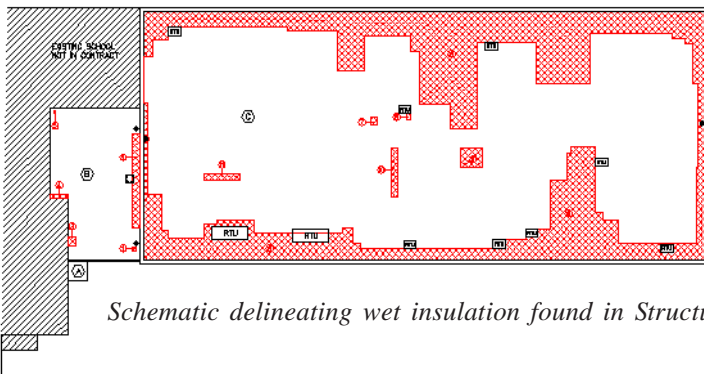
Schematic delineating wet insulation found in StructureScan.
