- **Location:**
Sterling Heights, Michigan
Plymouth, Michigan
- **Profile:**
Approx. 3 million square feet
- **Project:**
StructureScan Survey and
Roof Evaluation

Visteon Corporation Sterling Heights Facility

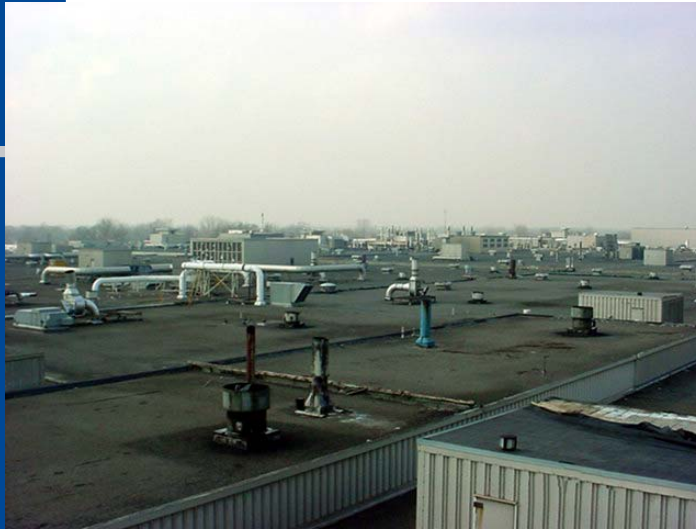
Overview of a portion of Sterling Heights Plant

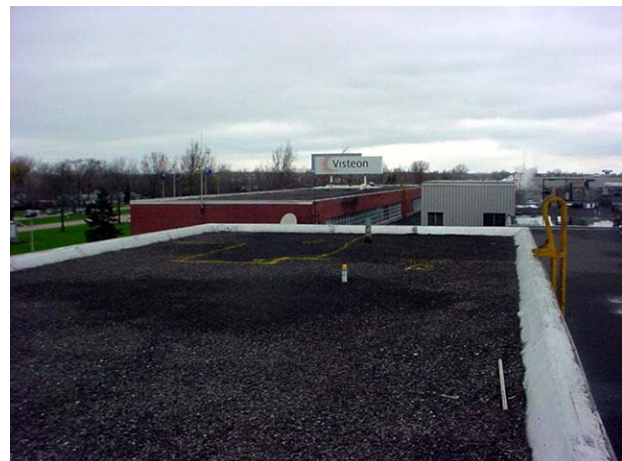
Areas of wet insulation were delineated on the roof using paint and were also denoted on detailed roof schematics.

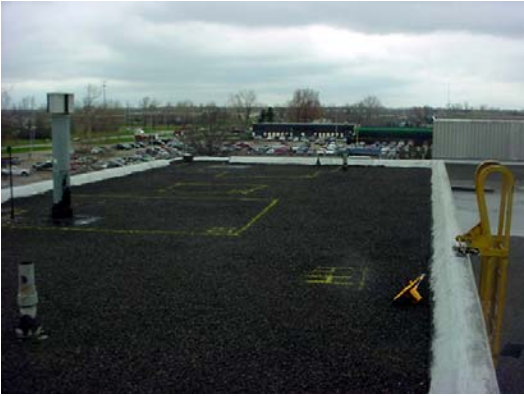
Approximately two million dollars of reconstruction occurred in areas exhibiting extreme degradation and wet insulation.

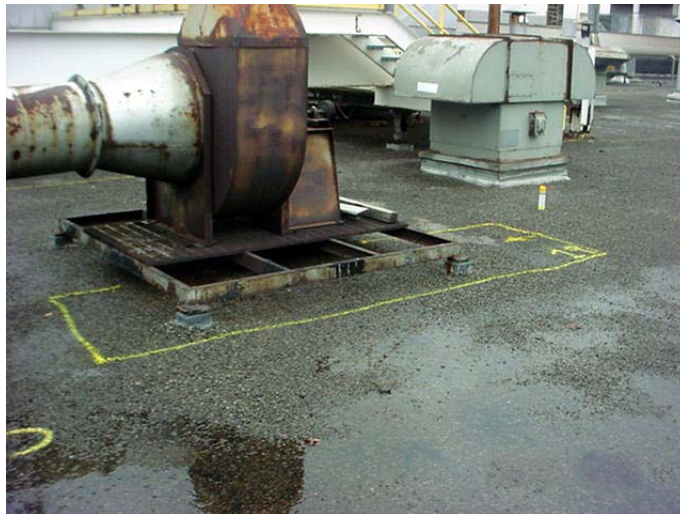
Many pieces of rooftop equipment exhibited areas of wet insulation due to inadequate flashings and extensive rooftop traffic.
