- **Location:**
Farmington, MI
- **Profile:**
Public High School
- **Project:**
Exterior masonry restoration

Services Provided:

Farmington Public Schools

Harrison High School

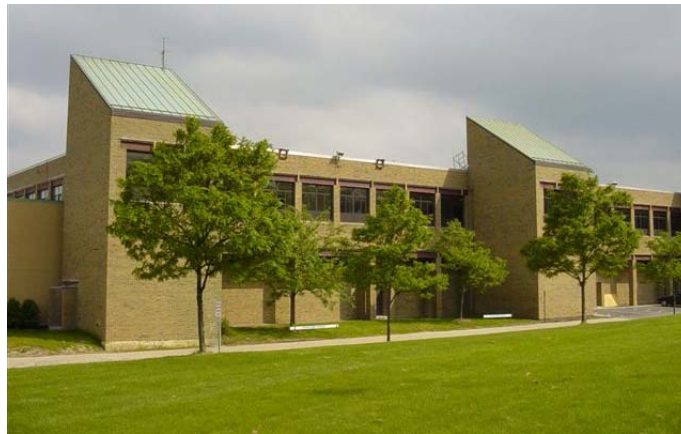
Overview of Harrison High School project in progress.

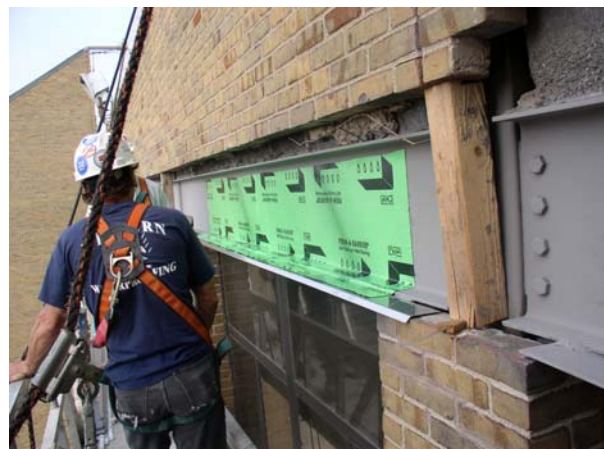
Embedded steel beams covered with two-component thru-wall flashing helped reinforce the structure.

tels, and shelf plates. These concise documents covered all aspects of restoring the masonry of the entire building. Work at the embedded steel included: removing exterior brick courses, removing existing flashing materials, thoroughly cleaning embedded steel to remove rust, reconditioning steel with a rust inhibitive primer, and applying a new protective paint coating. The work also included the replacement and/or strengthening of steel shelf plates. In addition, StructureTec specified new two-component thru-wall flashings for the exterior brick veneer embedded steel beams/shelf plates. The flashings combined fully-adhered membrane technology with durable sheet metal pan flashings for a long-term flashing detail.

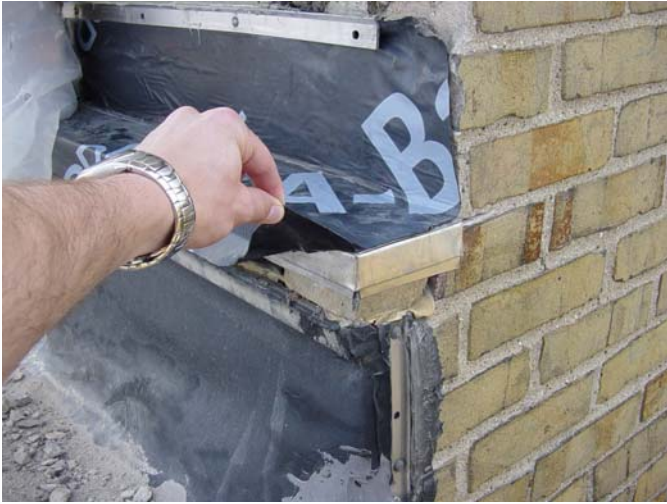
Installation of new flashing materials at the roof interface on the back sides of towers. Membrane materials require trimming for proper installation.

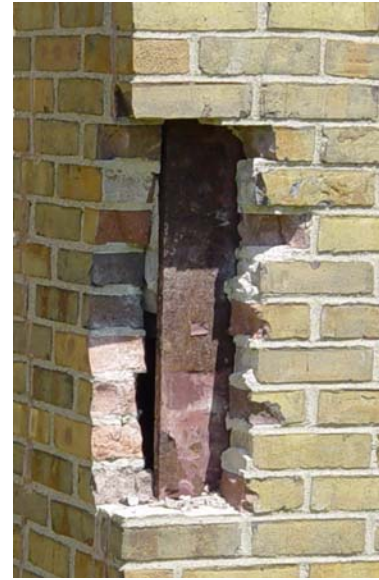
face staining below window mullions was present. Yet, the largest deficiency was the severely deteriorated embedded structural steel components. This careful evaluation determined that the watertight integrity of the building envelope had failed.

Bricks were removed at crack locations to expose rust deteriorated embedded steel columns.
