General Description:

- **Location:**
Lansing, MI
- **Profile:**
House of Representatives Building
- **Project:**
Platinum ProgramSM - Restoration

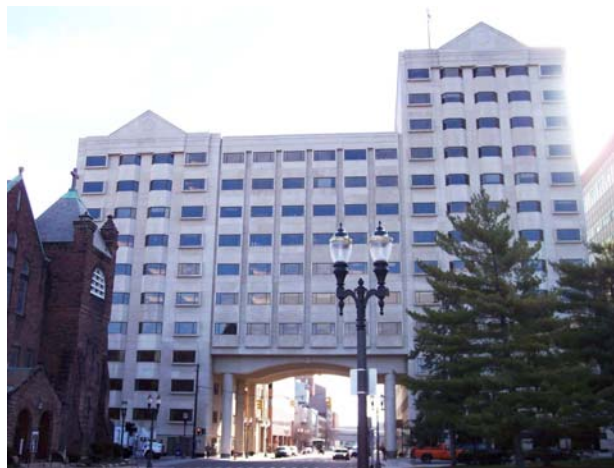
*Overview of Michigan House of Representatives
Anderson House Office Building*

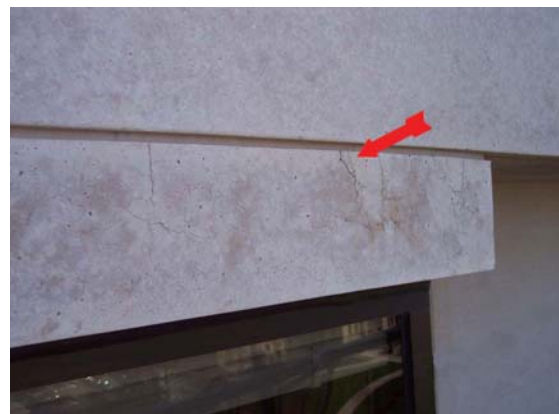
*Crack in precast concrete panel
allowing water infiltration*

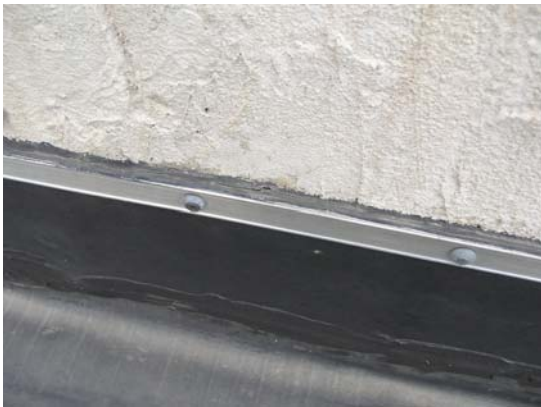
Failed sealant along top of roof flashing termination bar allowing water infiltration (Inadequate design and construction of original flashings)

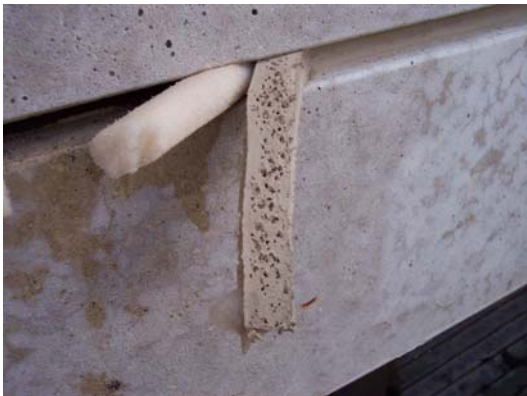
Voids in joint sealant between precast pane causing premature failure and openings

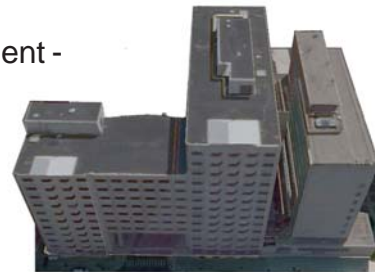
1. Evaluation - Building
2. Evaluation - Wall Cavity
3. Design Development - interior wall repairs
4. Field Quality Assurance
5. **Platinum Program**SM - Oversee interior wall repairs
