General Description:

- **Location:**
Detroit, Michigan
- **Profile:**
Energy Substation Facility
- **Project:**
Building Envelope Evaluation & Wall Analysis

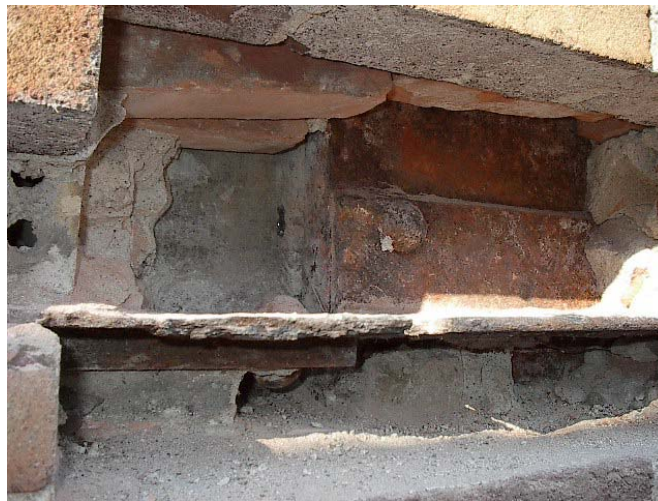
Overview of partially exposed steel column and roof beam exhibiting minor surface rust and corrosion.

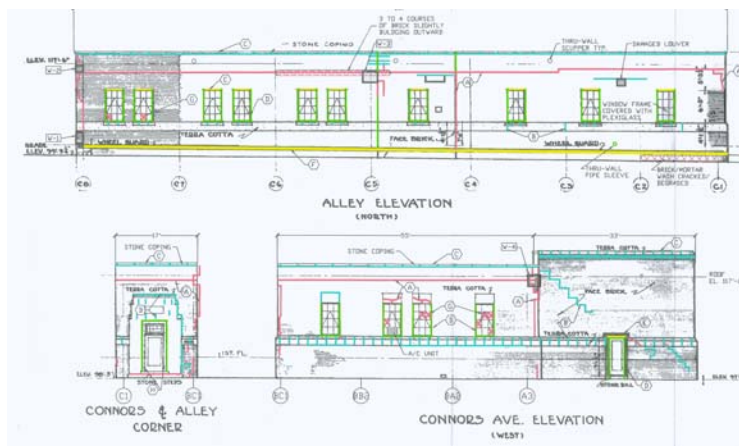
Schematic of Chandler Substation.

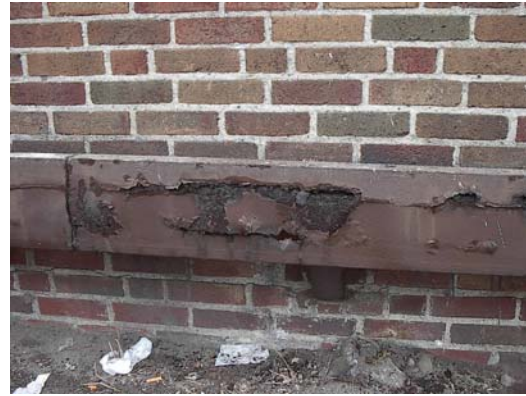
Rust and corrosion evident on steel guardrail along the base of wall.

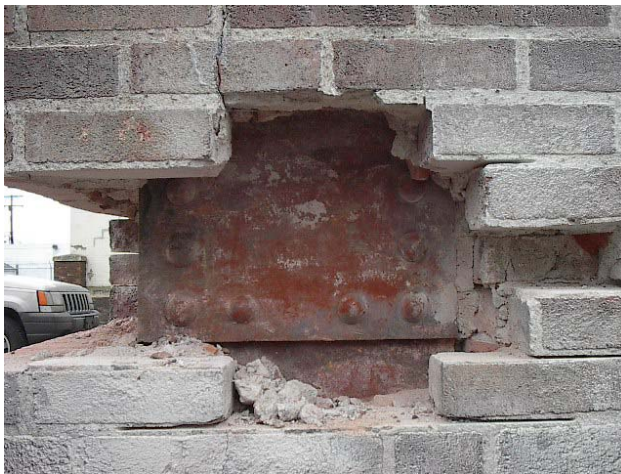
Wall opening allows embedded steel flange and splice plate to be observed.
