- **Location:**
Kalamazoo, MI
- **Profile:**
31,500 sq. ft.
- **Project:**
Roof Replacement

Kalamazoo Public Schools *Arcadia Elementary School*

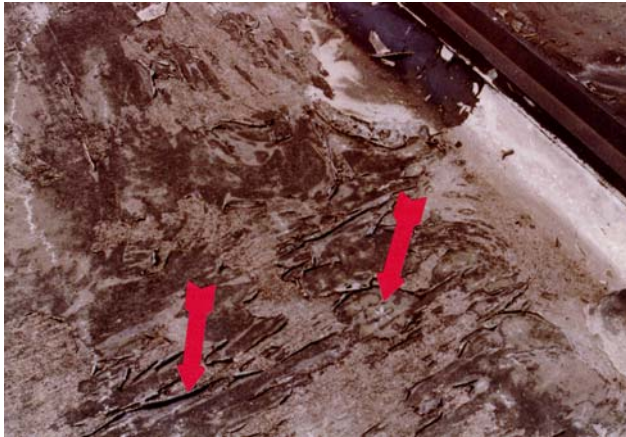
The existing roof experienced "ponding" water conditions up to six inches in depth at some locations. There were extreme areas of bare exposed felt. Splits and fractures

Previous roof had bare exposed felt which allowed "wicking" of moisture into the roof system..
