**General Description:**

- **Location:**  
Paw Paw, Michigan
- **Profile:**  
High-sloped deck over cold storage freezer facility
- **Project:**  
Roof Reconstruction  
Single-Ply System

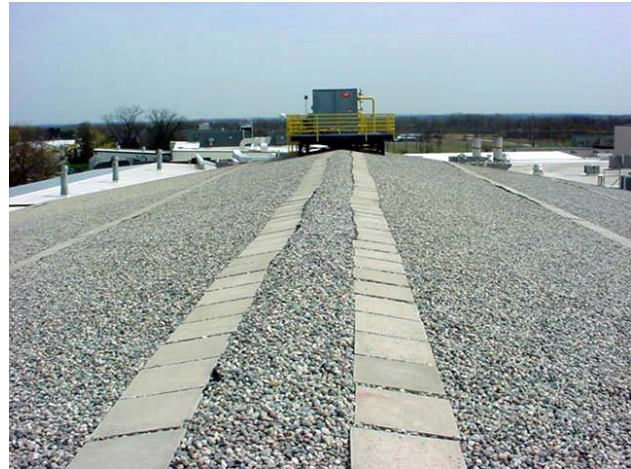
*Overview of completed reconstruction.*

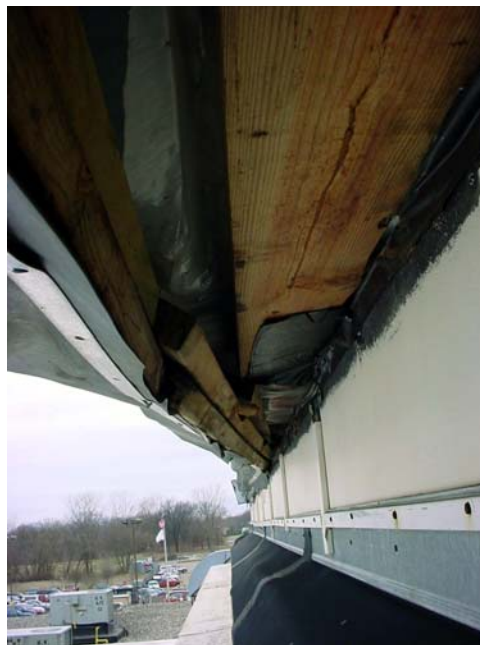
*Perimeter edge nailers had come loose, migrating from the edge and causing the exterior flashing to come unfastened.*

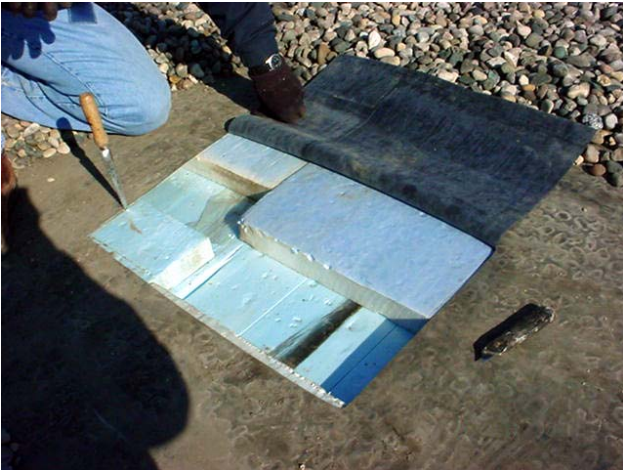
*Migrating ballast caused the insulation underneath to become displaced and damaged.*

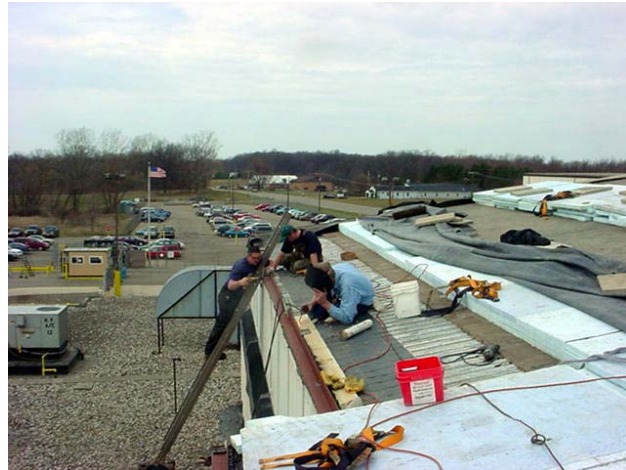
*Perimeter edge details were reconstructed with adequate structural integrity to support the weight load of the roof.*
