- **Location:**  
Elgin, Illinois
- **Profile:**  
Seven Buildings
- **Project:**  
*StructureScan*® Survey &  
Roof Evaluation

**School District U-46***Chicago - A Tradition of Excellence*

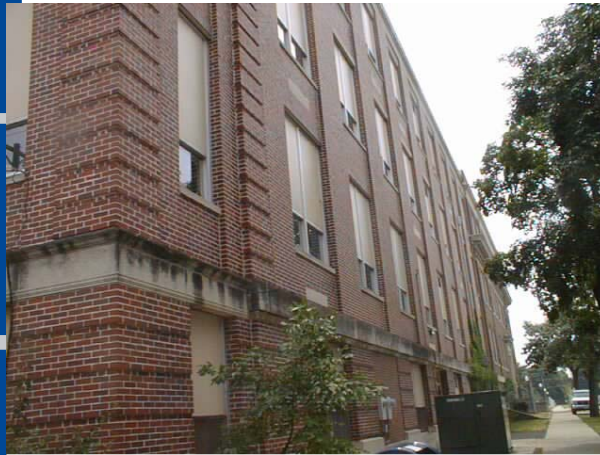
*Overview of Central Alternative High School*

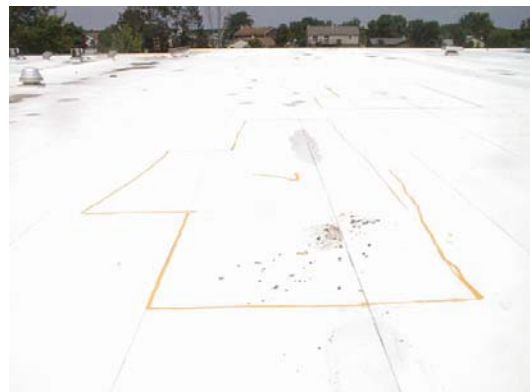
ited retrofit roofing, whereby single-ply roofing was installed directly over the existing built-up roofing. In the retrofit process, the existing wet, saturated insulation and substrate had not been addressed. This was compounded by the fact that the retrofits were mechanically attached and therefore had been compro-

*Overview of mechanically attached single-ply membrane assembly.*

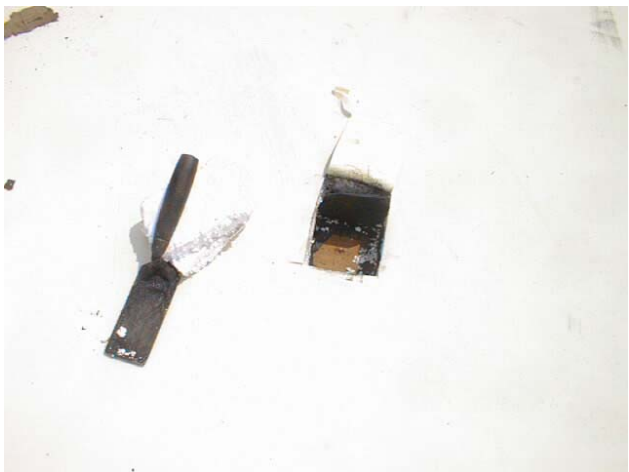
mised by the wet insulation from the time of installation. As a result, the majority of these retrofits were less than ten years old and had already experienced premature failure. Of the buildings surveyed, over 50% of the roofs required major remediation or replacement within the next five years. An additional challenge arose from the fact that the district had a very limited initial budget and lacked the funds to address all of the immediate areas of concern. Areas which could be restored through remedial repair and replacing wet insulation were delineated. The Survey's scientific approach and accuracy allowed School District U-46 to pinpoint and prioritize

Test cuts revealed overall construction. Retrofitting had occurred and existing insulation appeared saturated.

the remedial work to be completed, thus eliminating guesswork. The areas which absolutely required replacement were strategically prioritized into a long-range plan. In conclusion, all of the information obtained was used to support the district in establishing a bond issue process fund. These efforts enable them to undertake all the necessary capital projects and achieve the greatest return on investment. ■

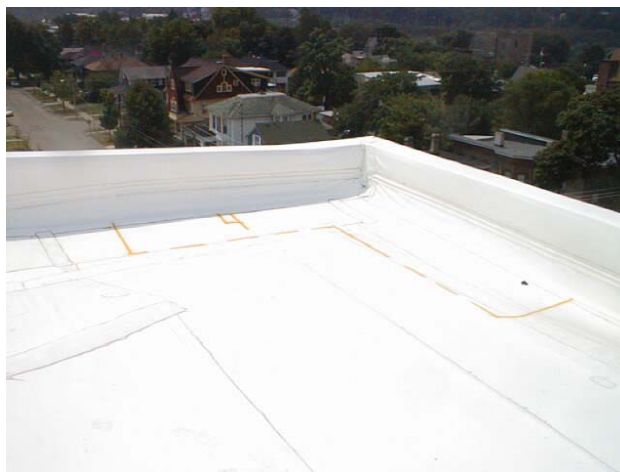
Overview of wet insulation identified during the StructureScan® survey.
