Total Building Envelope Management SolutionSM

MEMO FROM THE PRESIDENT

Campus-Wide Asset Management Programs

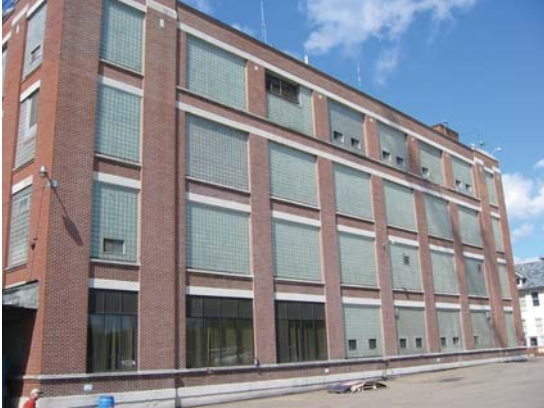
Masonry wall facades dominated the structures of the complex.

noted when the evaluation was completed was the widespread deterioration of maintenance-type items such as sealants. Also noted was a severe deterioration of masonry and concrete components due to the corrosion of embedded steel elements, which had experienced excessive exposure to moisture for many years.

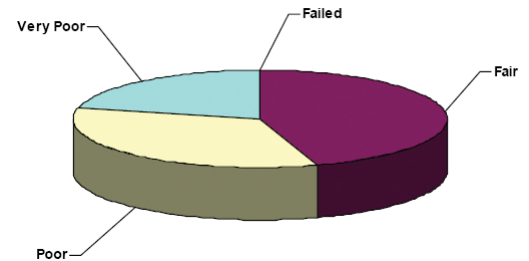
Kraft - Post Division Wall Condition Index

FEATURES	BENEFITS
Develop a Weatherproofing Condition Index (WCI) rating.	Prioritized inventory of all facility assets.
Prioritization which encompasses all building envelope components.	Establish budgets for future work in chronological order.
Delineates which building envelope components require restoration and which require maintenance.	Able to allocate their resources properly, maximizing the return on investment

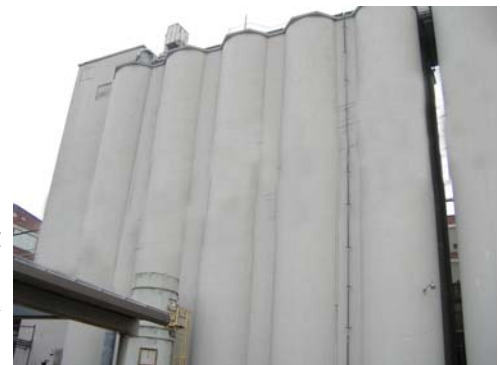
Concrete silos scattered the complex

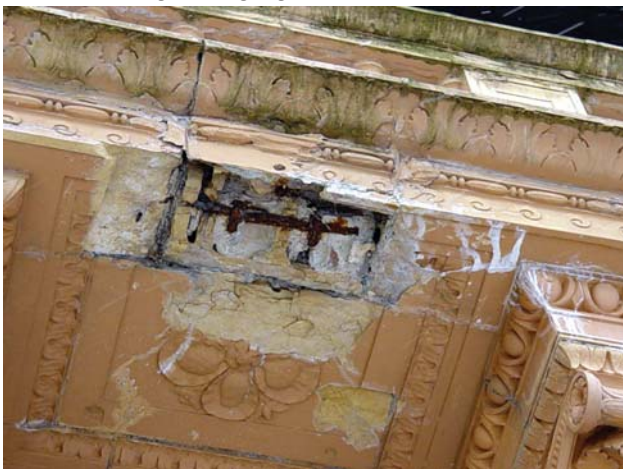
The spalling of the terra cotta on the balcony was caused by the rusting of the embedded steel, as well as extensive freeze/thaw cycles.

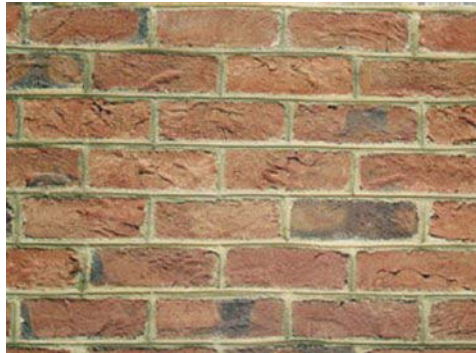
Similarly, warped brick raise similar concerns. First of all, brick off the pallet can be visibly warped, yet pass the ASTM standard. Secondly, warped brick are difficult to install

because of required vertical tolerances on sight lines. Lastly, once installed, the warped brick cast non-uniform shadow lines. Between the brick being visibly warped and non-uniform shadow lines, the appearance of the wall is detracted. Again, manufacturers stand behind the

As identified by many sources, including an article by The National Brick Research Center in Clemson, South Carolina, face cracking is a defect formed during the manufacturing process. Similarly, warpage is also caused during the manufacturing process. Face cracking and warpage are typically caused from drying and/or firing too quickly or slowly, non-uniform heating and cooling during drying and firing, poor particle size distributions, or initial moisture contents. Additionally, many of these sources continually present corrective actions to prevent such defects. It is apparent that both of these issues can be corrected during the manufacturing process, and should not be accepted.
