- **Location:**
Petoskey, MI
- **Profile:**
Hospital
- **Project:**
Platinum ProgramSM -
Exterior masonry restoration

Northern Michigan Hospital

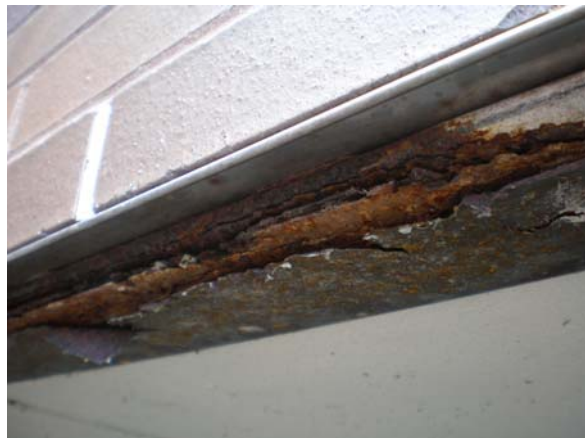
*Corroded lintels observed and detected during a **StructureScan**TM survey*

the buildings facade. Further investigation showed this was attributed to an additive in the mortar, which was degrading the steel joint reinforcement. A full building survey was conducted at NMH, which showed that the additive was contained in only one building. However, a number of other deficiencies, such as, corroded lintels, deteriorated sealants, damaged masonry, etc., were identified.

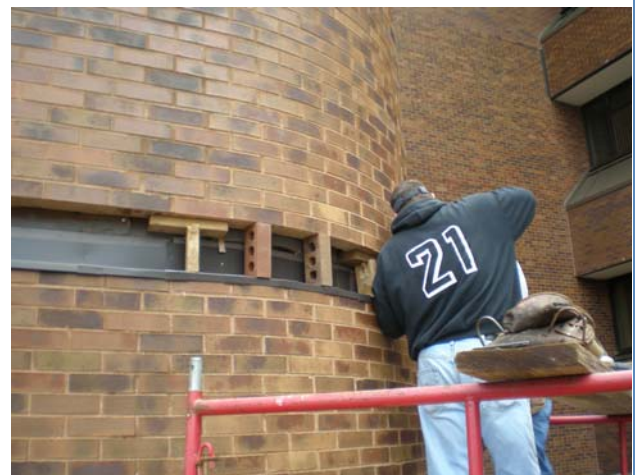
Sheet metal used to conform to the curvature of the masonry

attention must be paid in order to avoid any disruption during the client's operations. The first phase was conducted directly over the emergency room and survey wing. The second phase was performed at the exterior walls of the child delivery rooms. Additionally, mobile MRI and PET scanners were frequently placed directly below work areas, and a main hospital entrance was also present below the work area. Technical challenges included providing sheet metal-through wall flashing to conform to the curvature of the masonry.

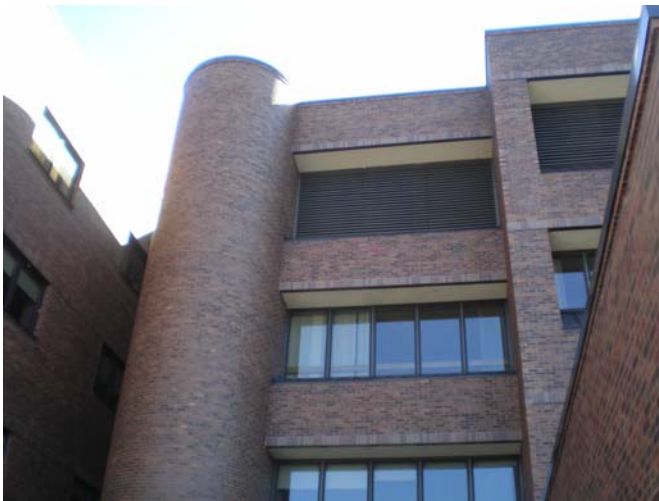
Overview of building envelope post construction
