- **Location:**  
Zeeland, MI
- **Profile:**  
Manufacturing Facility
- **Project:**  
Tower Panels - Dispute Resolution & Restoration

## Mead Johnson/Bristol-Myers Squibb ZIPP Tower FORENSIC INVESTIGATION

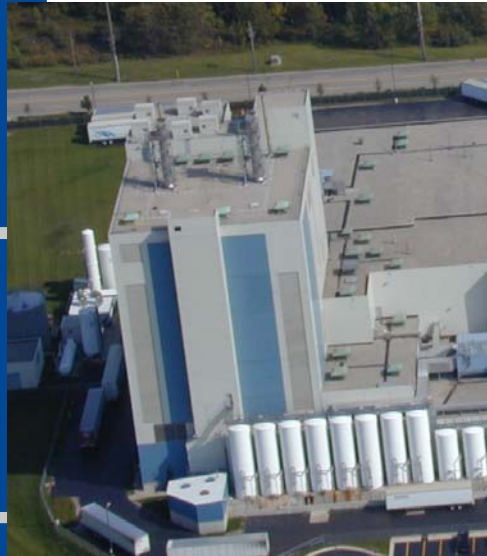
*Overview of completed restoration.*

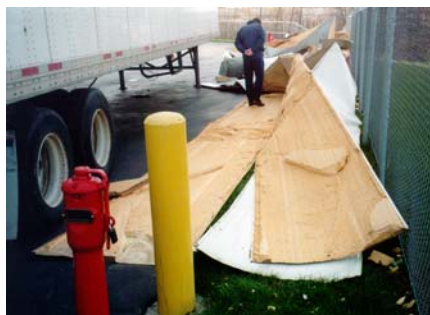
*Twelve panels blew off the tower, landing in the nearby parking lot.*

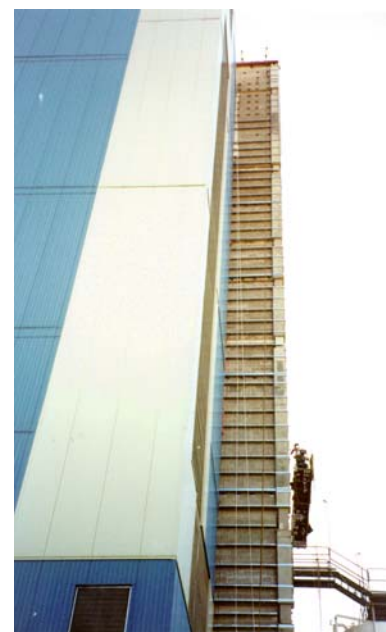
*All deficient panels were replaced on the tower.*

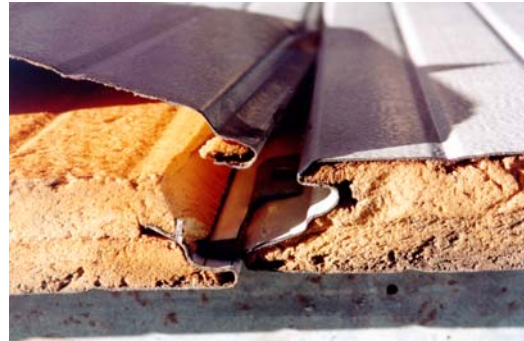
*Exterior cladding consisted of sandwich panels with an outer metal skin and insulation in the middle.*

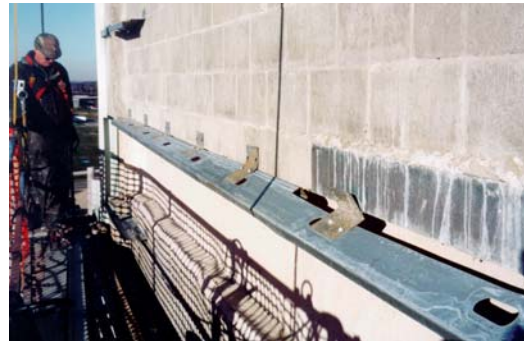
*Extensive observation and analysis was performed on the existing construction to determine the cause of the failure.*

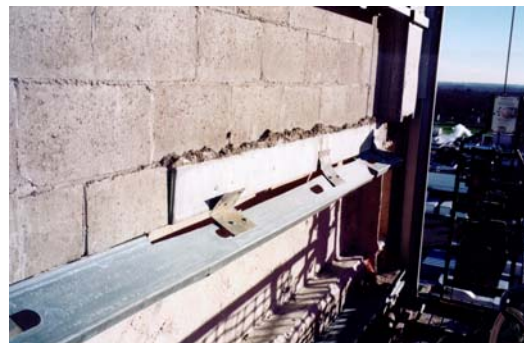
*A deficient subframing system was one of the primary causes of the blow off.*

StructureTec investigated the original construction documents, the exterior metal walls panels (both attached and blown off), and the subframing and connection details. The weather on the day of the blow off was also noted. Wind speeds had reached 67 mph, but the original criteria for the wall was supposed to be based on a design wind speed of 85 mph. By analyzing the construction documents and the construction components, StructureTec was able to determine that the blow off was attributable to two primary conditions. The first included deficient and/or omitted fastener connections for the exterior metal panels and wall corner details. The second was the erection of a deficient subframing system. The final conclusion was that it had been both a design flaw and workmanship errors. StructureTec generated an attorney work product and then worked with Mead Johnson corporate counsel through many months of negotiations to ensure a resolution whereby Mead Johnson would incur no cost to repair both the areas of blow off, as well as other areas of the tower which were affected with similar flaws – preventing potential future problems. StructureTec then worked to redesign the structural system and performed field quality assurance to ensure the final project exuded the necessary quality. In conclusion, Mead Johnson was able to have their situation resolved, creating a watertight, safe facility which will now yield the greatest return on investment. ■
