- **Location:**  
Battle Creek, Michigan
- **Profile:**  
Multistory Elementary Building
- **Project:**  
Steep Slope Roof

## Battle Creek Public Schools *Roosevelt Elementary School*

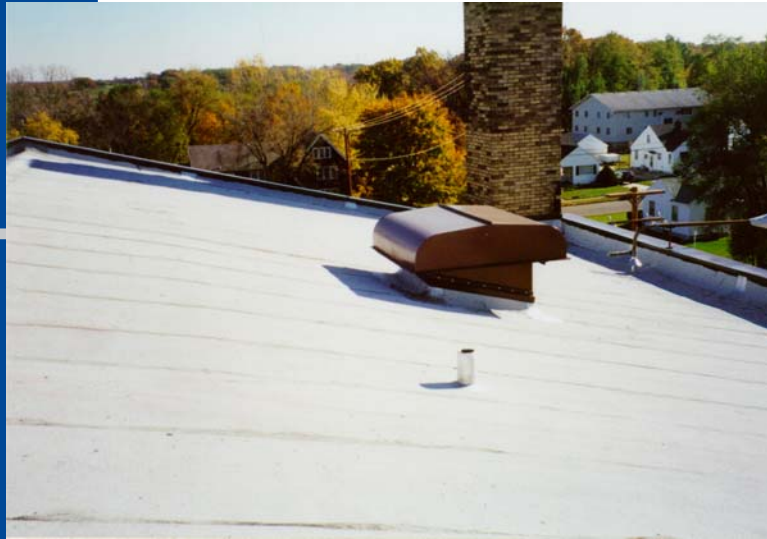
*Overview of completed roof replacement.*

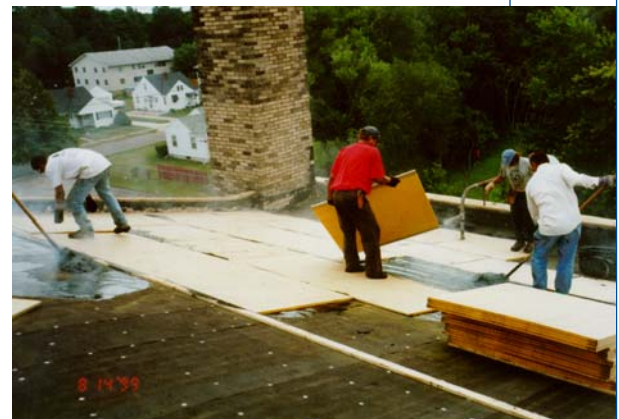
*Fully-adhered insulation board is being installed.*

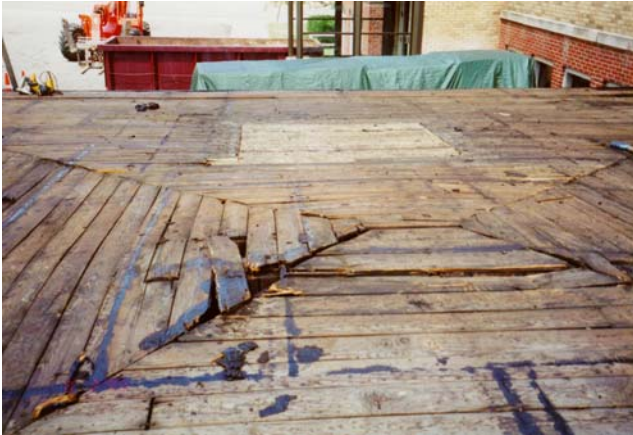
*Deteriorated wood decking was not structurally sound.*

dressed. Construction Documents were then developed and the project was bid. During the construction phase, the decking was replaced in areas which had rotted and deteriorated. These efforts were carefully coordinated and monitored in order to ensure

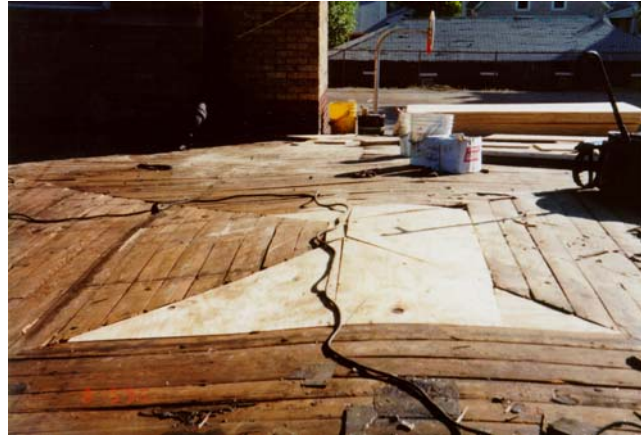
*Deteriorated wood decking was replaced with new lumber.*

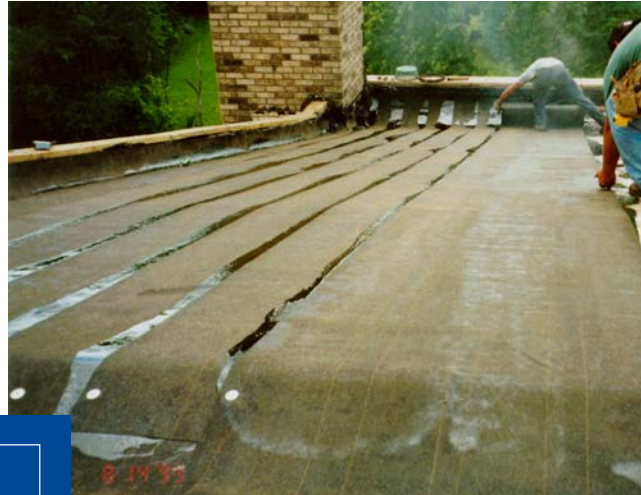
*Bituminous plies were installed overlapping and fully adhered.*

that everything was performed sequentially and in a timely manner. A temporary envelope had been created to ensure that the inside of the building would be protected during these efforts. A modified bituminous roof system was installed, consisting of three plies of fiberglass felt, as well as a modified bituminous cap sheet with a granular surface. The completed roof assembly conformed to a steep slope environment and was aesthetically pleasing when viewed
