- **Location:**
Battle Creek, MI
- **Profile:**
6,500 sq. ft.
- **Project:**
Roof & Deck Replacement

Battle Creek Public Schools

W. K. Kellogg Junior High School

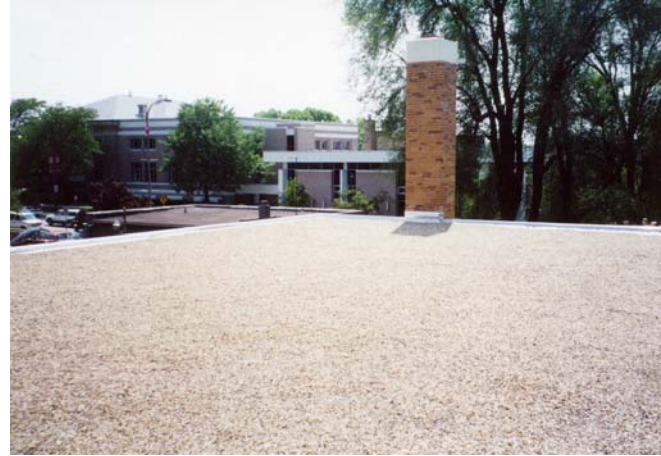
Overview of completed roofing project.

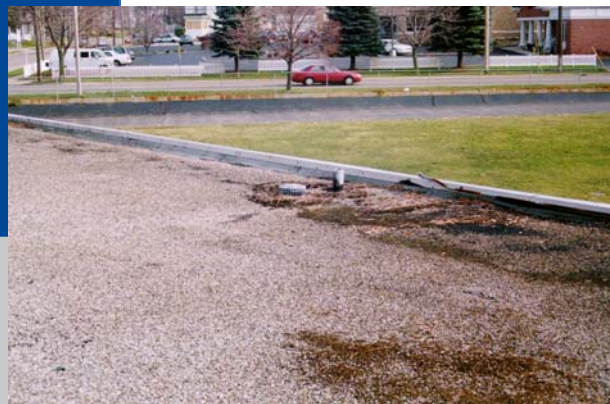
Extreme degradation, including vegetation, is evident on existing roof system.

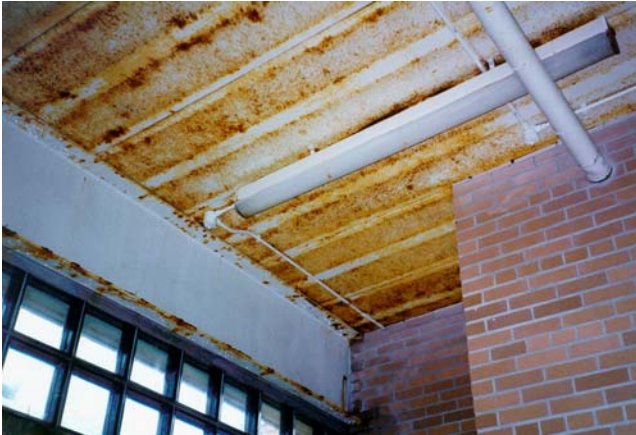
Metal roof deck is extremely rusted and degraded, requiring replacement. Structural steel beams have surface rust and lead-containing paint, requiring restoration.

that the metal deck was extremely deteriorated and required replacement. The structural beams then posed the next challenge. First they were tested for structural integrity and were found to be sound. Then means, methods, and procedures were investigated for the restoration of structural steel. The paint on the beams was found to contain lead, which would require abatement and removal. Another challenge arose from a short construction time frame. The project had to be completed during the summer and had to accommodate the men's and women's swimming schedules for the school district. This schedule was complicated by the fact that the project was extensive and required multiple trades and coordination. During the design phase, these challenges were addressed. A new steel deck was designed to replace the existing metal deck. The existing structural steel beams would be carefully sandblasted to remove lead-based paint.

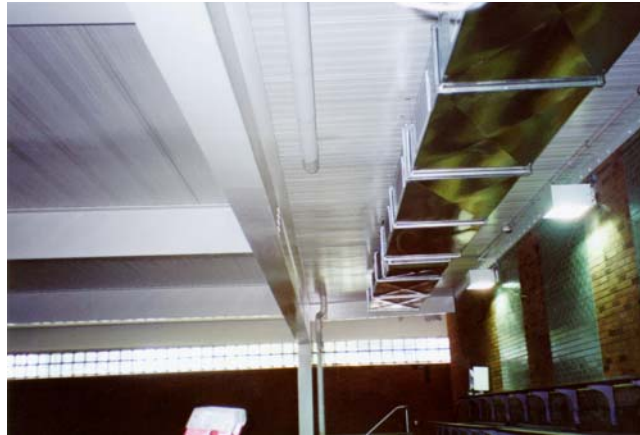
New steel deck and restored structural steel beams were cleaned and painted.

Both the new deck and the cleaned steel supports would then be painted with an anticorrosive system. The challenge of scheduling and multiple contractors was solved by utilizing a general contractor who oversaw the entire project. Special coordination between all parties was anticipated through pre-scheduled progress meetings. The Construction Documents were then written and the project was bid out. During construction, the deck and roof replacements were coordinated. An asphalt built-up roof was installed with insu-

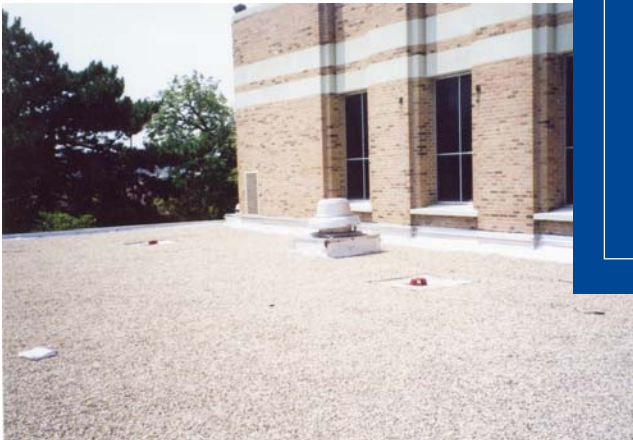
New drains and sheet metal flashings demonstrate attention to detail.
