- **Location:**
Holland, Michigan
- **Profile:**
Approx. 8,500 sq. ft. replaced
- **Project:**
Roof & Partial Deck Replacement

CDR - Pigments & Dispersions *Building 14*

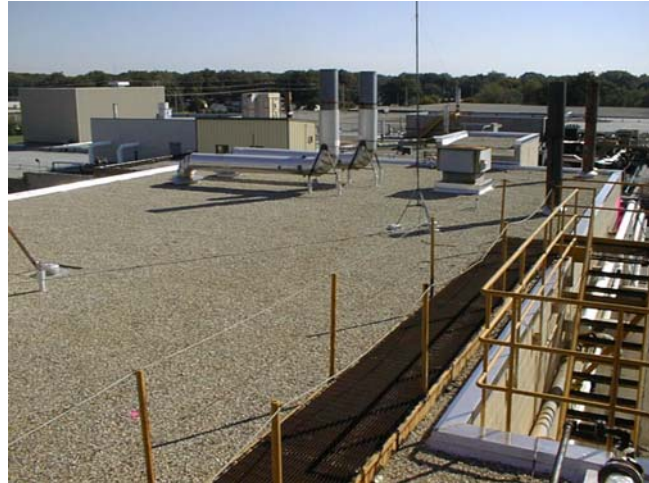
Overview of completed roof replacement.

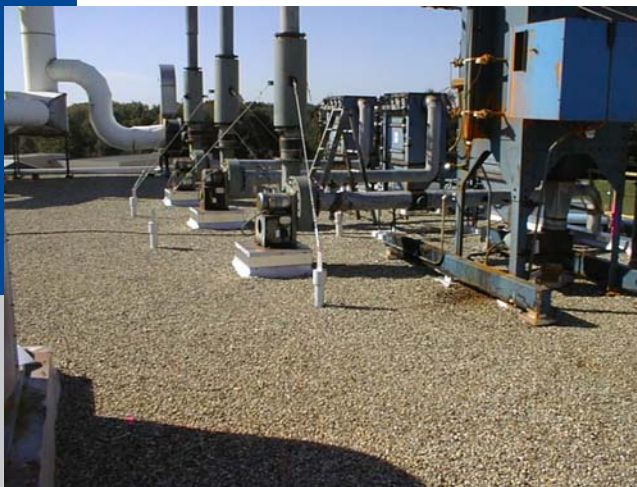
Extensive rooftop equipment and penetrations received careful attention to detail as flashings were incorporated into the roof replacement project.

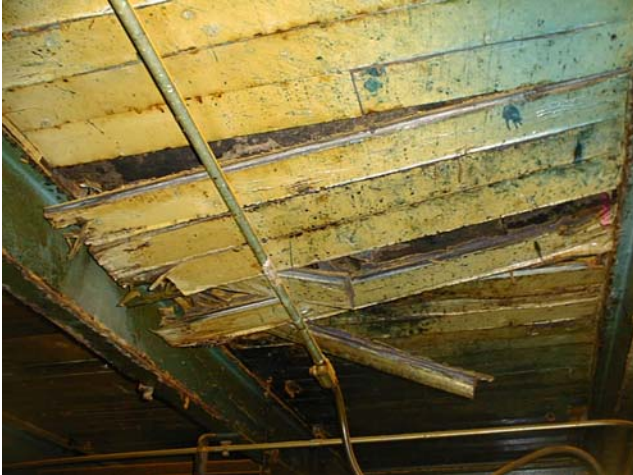
system, it was anticipated from the outset that significant deck degradation had occurred. This was confirmed with a structural analysis of the deck. This was the first chal-

Existing wooden deck was completely degraded due to the extensive, prolonged moisture ingress in the roof system.

New decking was installed to provide structural integrity for the roof and the rooftop equipment.
