- **Location:**  
Chelsea, Michigan
- **Profile:**  
Replaced approximately 35,000 square feet
- **Project:**  
Roof Replacement  
Built-up Roof

## Chelsea Milling Company

**"JIFFY" mixes**  
*Main Plant*

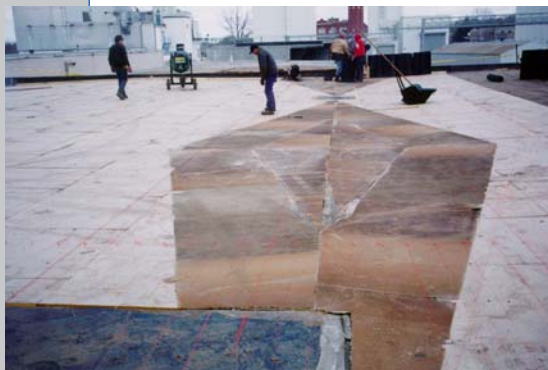
*Saddles were designed as a part of the new roof system in order to help eliminate ponding water.*

membrane splits at the metal edge. The adjacent masonry wall was in disrepair and required major reconstruction. A built-up roof system was determined to be the best long-term solution. During the design phase, tapered insulation saddles and crickets were proposed to help aid in water dispersion and prevent standing water. An additional challenge was addressed during this phase in that the roof replacement had to occur without disruption to the internal operations, which needed an absolutely sterile environment. Internal temporary protection was designed to prevent dirt and debris from entering the manufacturing process. This would allow the removal and replacement of the roof system without shutting down

the manufacturing process below. Construction Documents were then developed and the project was put out for bid. During the construction phase, the internal temporary protection and tapered insulation saddles and crickets were successfully incorporated. Proper drain installations were also undertaken to ensure that ponding water would no longer be a problem. A four-ply asphalt membrane was installed with a heavy asphalt flood coat and aggregate surfacing. New sheet metal covers with a standing seam configuration were installed after the expansion joints had been properly flashed. Architectural metal cladding was installed on the exterior walls in conjunction with the roofing project. In conclusion, CMC has a long-term, durable, watertight roof system which will protect their facility for many years. They were able to accomplish this without having to disrupt their processes or violate their sterile environment. This enabled CMC to experience the greatest return on investment for their project. ■

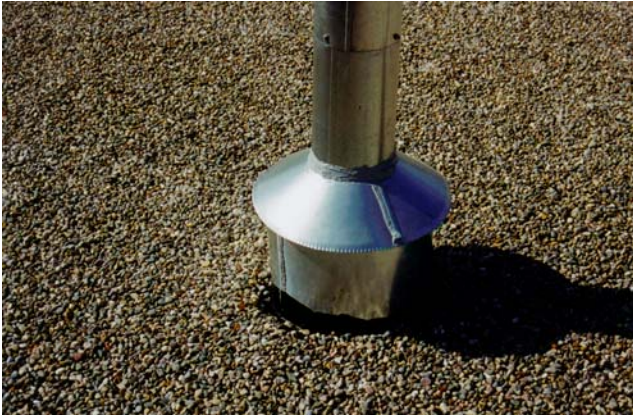
*Rooftop projection is properly flashed with a stainless steel sleeve and a rain collar.*

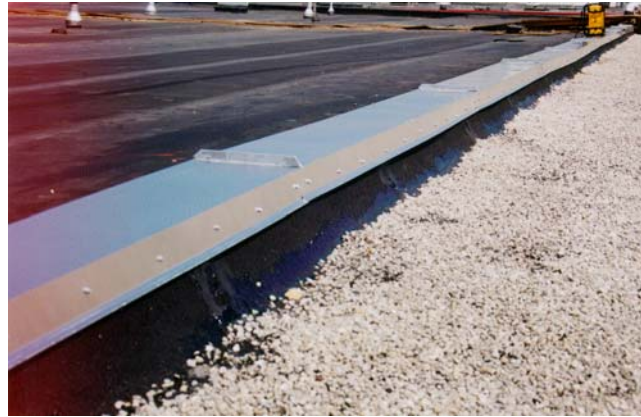
*Attention to detail is evident in the expansion joint flashing and sheet metal coping.*

Expansion joint detailing with metal cap/standing seam joints
