- **Location:**
Battle Creek, Michigan
- **Profile:**
Two College Facilities
- **Project:**
Roof Replacements
Grant-funded Upgrades

Kellogg Community College Learning Resource Center & Davidson Building

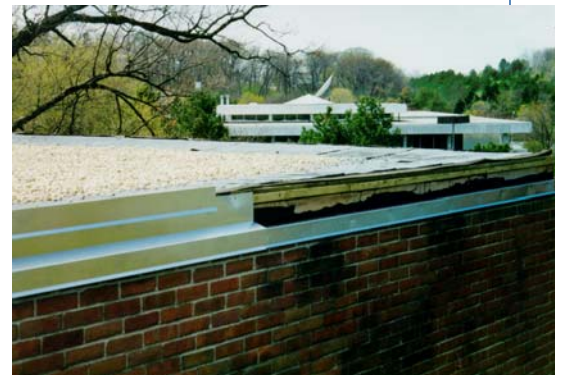
New fascia system was designed with careful attention to detail to allow for perimeter movement.

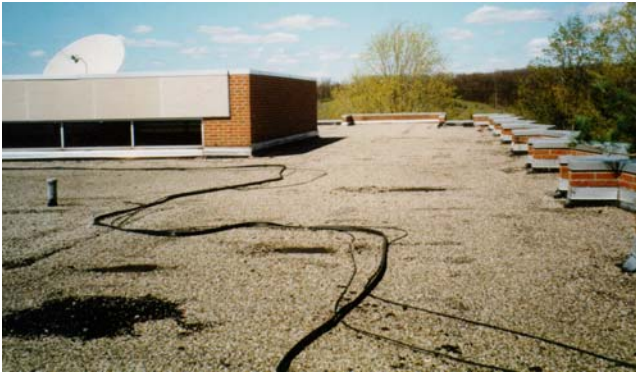
Existing roof was extremely degraded, experiencing leakage, and at the end of its service life.

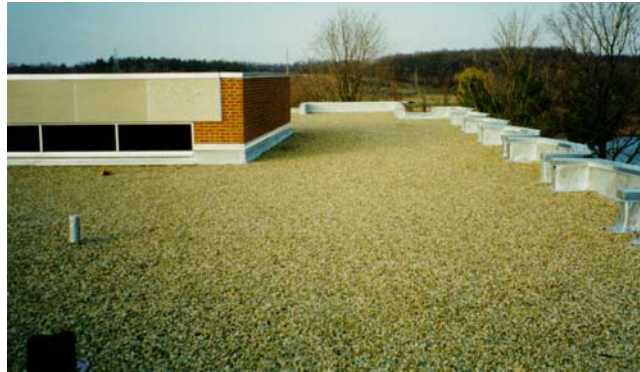
The new built-up roof system, which incorporated zoned insulation, replaced the original roof.

challenge arose from the fact that the roofs had been designed with a dead level deck. The perimeter walls were of inadequate height to design a tapered insulation system with proper flashings. The solution was to zone the insulation and add additional drains. Zoning is a process which

combines tapered edge strips with layering traditional insulation, creating a sumping effect where flashing heights do not allow for tapered insulation. Although it does not provide as much of a slope as a tapered insulation system, this assembly, combined with additional drains, is an enhanced solution to the problem of ponding water. Once all of the design challenges had been

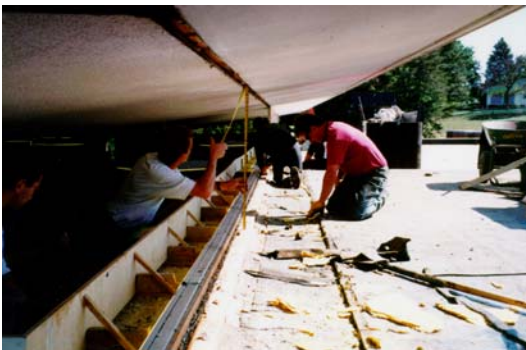
Original flashing heights around window panels were of inadequate height for watertight integrity.

that these internal operations were not disturbed. This challenge was met by scheduling progress meetings and maintaining good lines of communication with all parties involved. The next challenge arose from deficient flashing heights around the window panels at the high-bay/low-bay juncture. The original window panels were scheduled to be removed and replaced as part of the renovation. The flashing details were redesigned to achieve a proper height with watertight integrity. Another challenge arose from the fact that natural lighting was required at designated areas within the building. This was solved by designing a specialty skylight system with proper flashing details which allowed it to integrate with the roof system. A final chal-

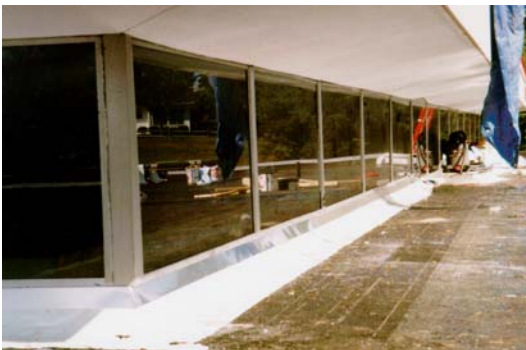
New flashing details and window panels were installed as a part of the roof replacement.
