- **Location:**  
Battle Creek, Michigan
- **Profile:**  
Corporate Building
- **Project:**  
Roof Replacement

## Kellogg Company *McCamly Place*

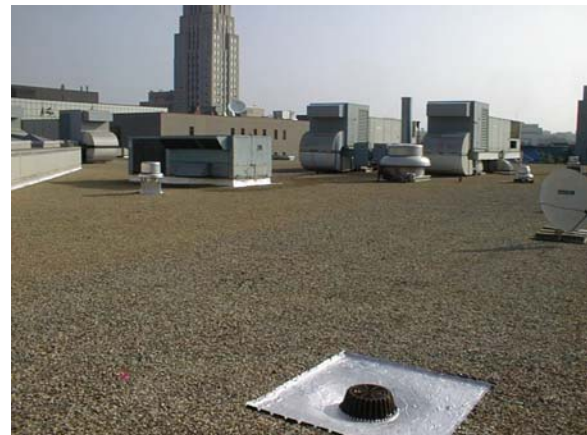
*Overview of completed roof replacement.*

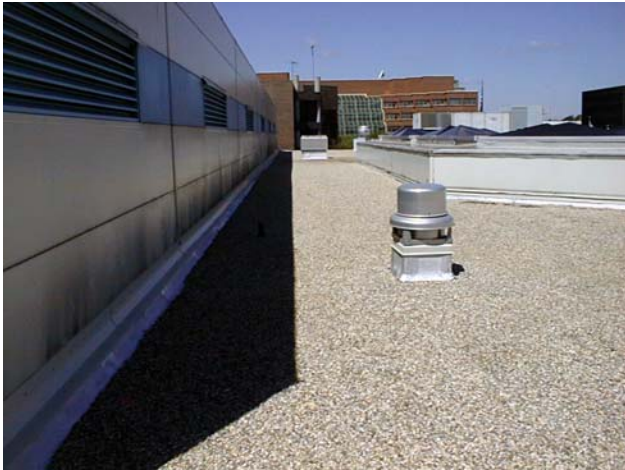
*A new tie-in was designed along the wall transition to accommodate movement and maintain watertight integrity.*

Tec then began designing the roof replacement. A built-up roof was chosen as the best solution, yielding the best life-cycle cost for Kellogg. The first challenge StructureTec tackled was with the tie-in. This was solved by redesigning the base flashing/expansion joint detail along the wall

StructureTec was contracted to evaluate and perform a StructureScan survey of McCamly Place, which is tied into the Kellogg Arena. During the evaluation, StructureTec found that the roof was deteriorated beyond repair and would require replacement. It was also determined that extensive leakage was occurring along the building transition between McCamly Place and Kellogg Arena, noting transition to accommodate movement and maintain watertight integrity for the wall and the roof. StructureTec then solved the chal-

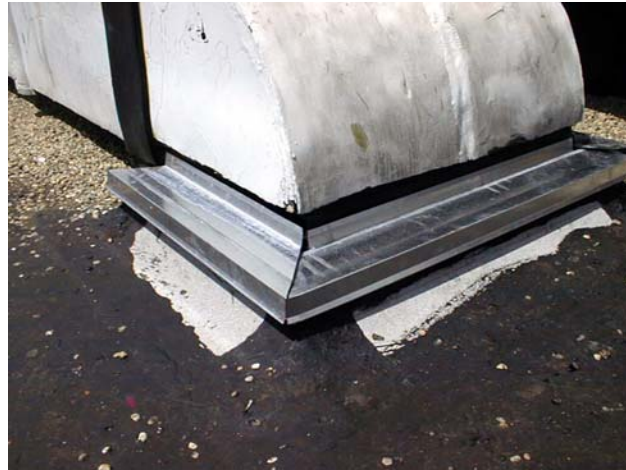
*Tapered insulation, crickets, and saddles were installed, particularly around projections, to provide water dispersion.*

length of the ponding water by designing tapered insulation crickets and saddles, particularly around various rooftop projections, to allow positive water dispersion toward the roof drains. After the design was complete, construction documents were written and the project was put out to bid. StructureTec completed Field Quality Assurance during construction in order to ensure that the highest quality was maintained throughout the project.

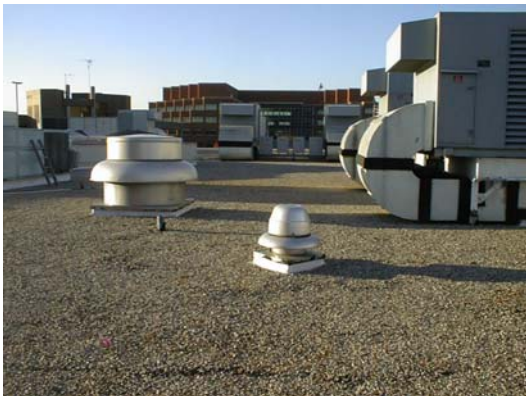
*The new built-up roof, known for its longevity and durability, will provide Kellogg Company with the maximum return on investment.*

In conclusion, Kellogg Company had a new, built-up roof with the necessary provisions for positive water dispersion, as well as expansion and contraction at the wall tie-in. This durable roof, known for its longevity, will provide Kellogg Company with the maximum return on investment. ■
