- **Location:**
Mendon, MI
- **Profile:**
19,600 sq. ft.
- **Project:**
Metal Roof Assembly
Installation

Lear Plastics Corporation *Plating Building*

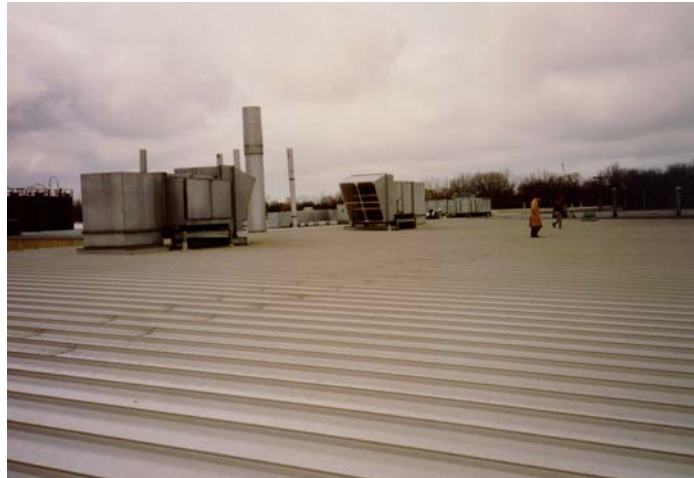
Overview of field of roof

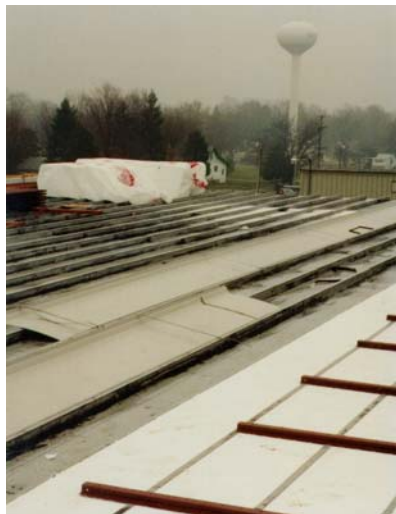
The new metal roof was installed retrofit over the existing metal roof.

sembly. In the process, obsolete rooftop equipment was removed and new decking was installed to match existing decking. Expanded polystyrene insulation was installed over the existing substrate. The new metal roof assembly was installed and secured to the new support structures. Metal flashing and elastomeric flashing were fabri-

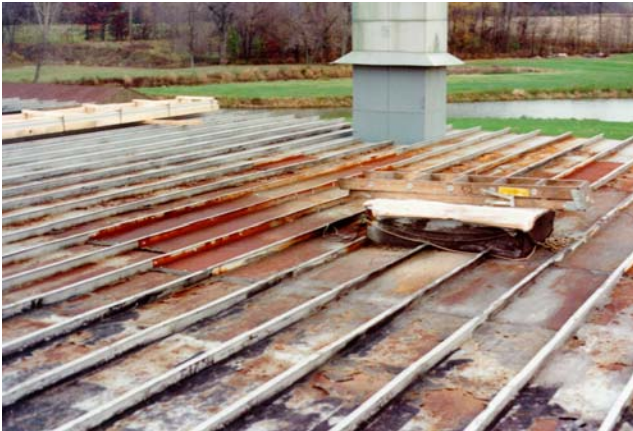
Corrosive chemicals from the plating manufacturing process were expelled from the roof top projections and resulted in massive corrosion to the existing metal roof assembly.

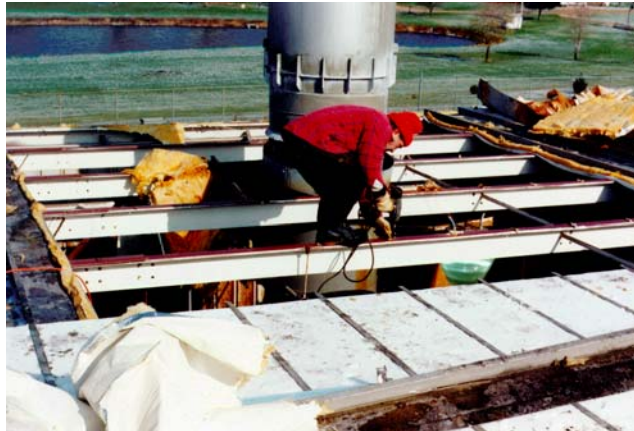
Complete removal of the existing metal roof assembly was required due to the extensive degradation of the original system.
