- **Location:**
Otsego, Michigan
- **Profile:**
Paper Manufacturing Plant
- **Project:**
Construction of new building over existing building

Menasha Corporation Secondary Fiber Building

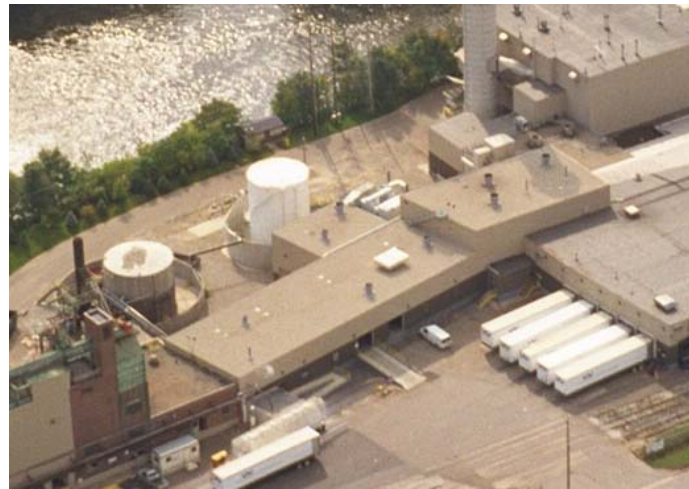
Overview of the completed new building.

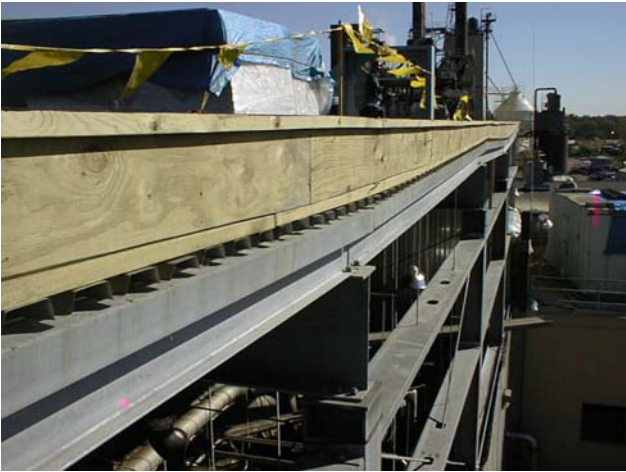
New structure was constructed over and around existing building.

three of the walls and the roof and deck then demolishing the original building inside the new structure and removing the refuse before completing construction on

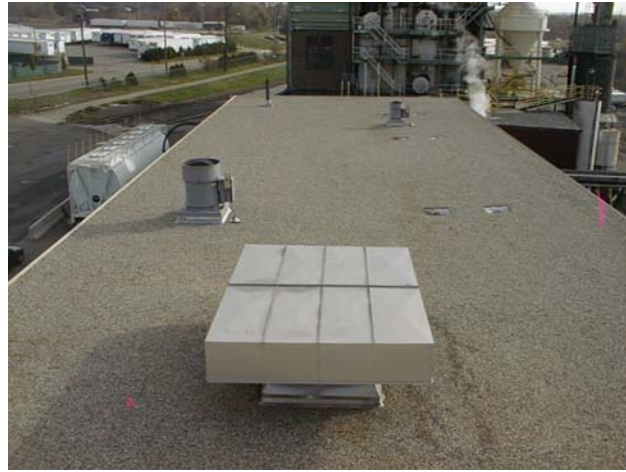
New roof assembly included built-up membrane with modified cap sheet, flood coat, and roofing aggregate.

water from developing and causing stress to the roof system. The design of the new roofing consisted of an asphalt built-up roof membrane overlaid with a smooth surface, modified bitumen cap sheet. The design also included an asphalt flood-coat over the system

with roofing aggregate imbedded in the flood-coat for a protective FM approved finish. This design ensured that the high foot traffic necessary to accommodate the rooftop equipment would not damage the roof. The final design was a roofing assembly which was highly protected from humidity below and foot traffic above. The Construction Document package was then assembled. StructureTec assisted in the bidding process, ensuring that the specialized contractor selected was capable of performing the highly technical aspects of the job. Extensive Field Quality Assurance was employed to make certain that the high standards necessary were employed during the workmanship phase. The finished product included a roof deck and assembly which would safeguard the manufacturing process below. In conclusion, Menasha Corporation was able to maintain operations while constructing a durable, long-lasting new facility to house their production process. The specialized design of the roof system, deck, and structure will ensure that Menasha has a building which will yield the highest return on investment. ■
