- **Location:**
Battle Creek, Michigan
- **Profile:**
Manufacturing Facility
- **Project:**
Roof Replacement, Roof Repair, and Wall Remediation

Michigan Paperboard Battle Creek Manufacturing Facility

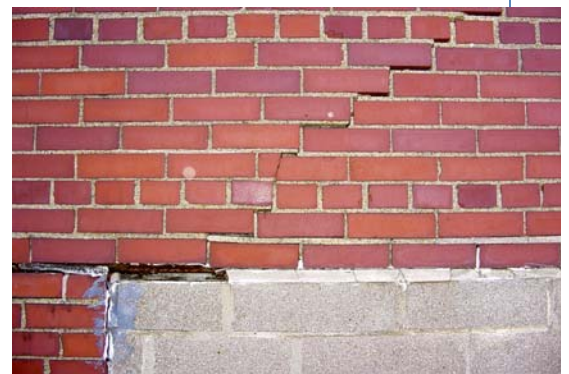
The masonry wall was exhibiting significant distress and required structural remediation.

concern by designing a tuckpointing and cladding solution. The structural integrity of the wall would be restored with the tuckpointing. The watertight integrity of the wall would then be ensured by installing a metal cladding system over the wall. This solution was economical, aesthetically pleasing, and solved the problems. StructureTec then wrote the specifications, bid the project, and began conducting Construction Review and Administration to ensure qual-

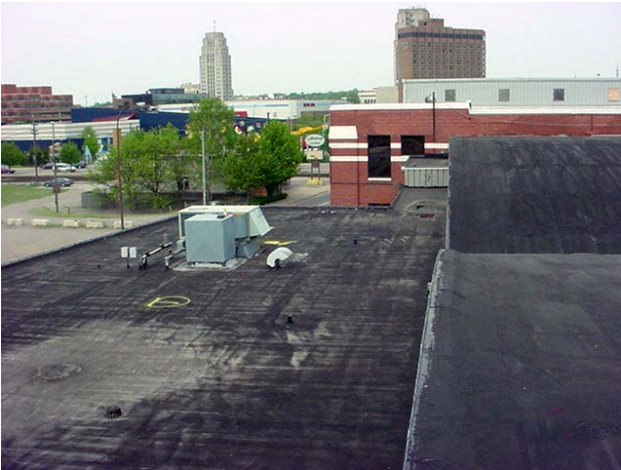
The roof was experiencing significant distress and required replacement. (BEFORE)

inadequate and random intermittent moisture had been present for many years, which had degraded the deck. StructureTec solved this by designing a fully tapered insulation system with additional roof drains, as well as deck replacement in required areas. The next challenge that arose was a void that existed between the low slope roof

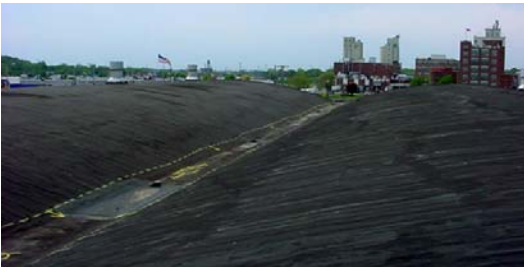
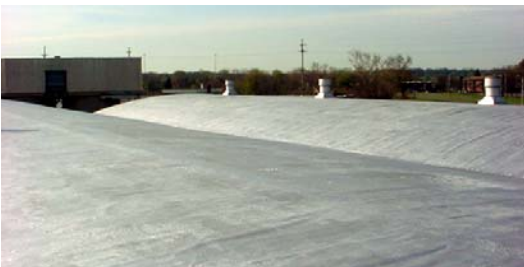
Before...

...and After

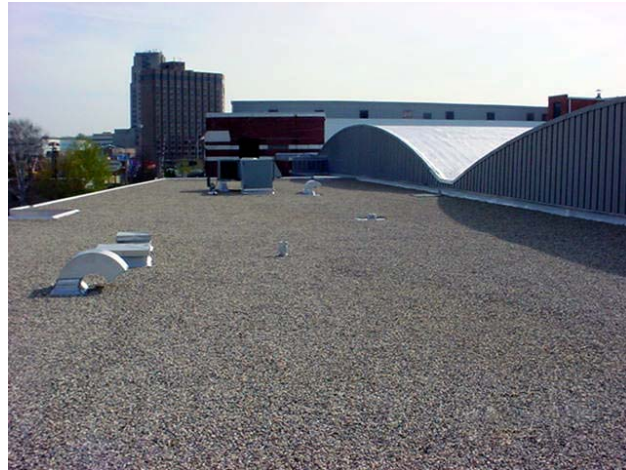
A new slip insert counterflashing and deck replacement were part of the roof replacement project. (AFTER)

base flashing and the existing metal wall system. StructureTec solved this by designing a special sheet metal counterflashing that would be installed in conjunction with the new base flashings for the roof system. The masonry wall also posed a challenge. The wall was experiencing significant structural distress and lacked wa-
