- **Location:**  
Adrian, Michigan
- **Profile:**  
150,000 sq. ft. of masonry
- **Project:**  
Restoration and Cleaning of Exterior Masonry Walls

## Christian Family Foundation Lenawee Christian School/ Christian Family Centre

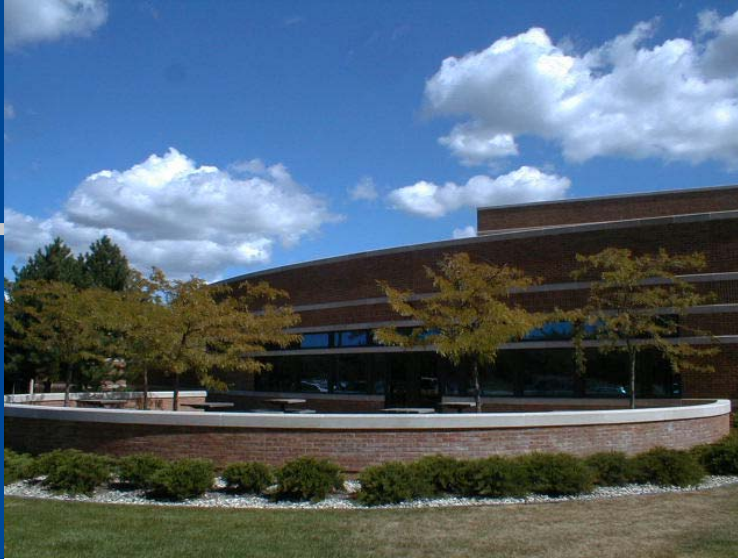
*Overview of Lenawee Christian School*

sorry walls at their facilities over the ten year period following completion of the original construction. Christian Family Foundation had been unable to determine the cause of the leakage conditions. A comprehensive evaluation was performed consisting of exploratory removal of masonry units to review existing through-wall flashing details. This evaluation revealed that none of the existing through-wall counterflashing provided water-tight integrity to the building. In addition, porosity testing of the exterior brick veneer was conducted and this test revealed that the masonry was extremely porous and absorbing moisture. The evaluation phase also re-

scope of work. This work had to be completed without damaging the existing roof systems. It was decided that a swing-stage set-up would be required for the construction phase to protect the roofs. Restoration involved correcting areas of existing masonry distress,

tuckpointing deficient mortar joints, reconditioning rusted steel lintels and installing a new through-wall flashing system for exterior brick veneer at upper wall levels. The flashings were a com-
