- **Location:**
Niles, Michigan
- **Profile:**
Multilevel Masonry Structure
- **Project:**
Restoration of Exterior Walls

Niles Community Schools Eastside Elementary School

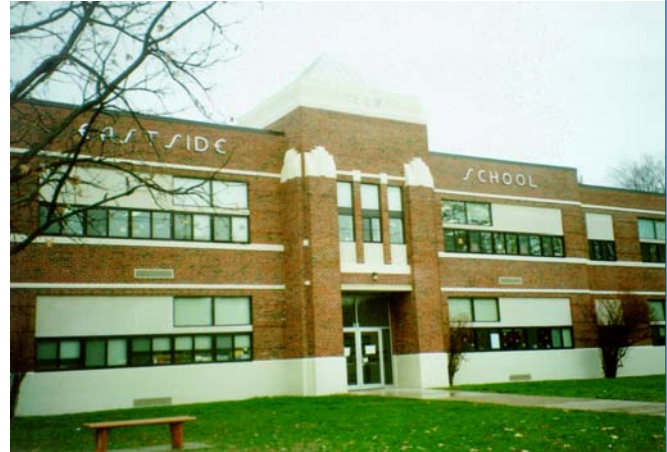
Eastside Elementary School was experiencing profuse leakage conditions, as well as obvious visible structural distress. Masonry brick surfaces were eroding due to aging and weathering. Decorative concrete features and foundation walls were cracking and spalling. Efflorescence was present on masonry brick surfaces. Deterioration also included masonry mortar joints and steel window lintels. Window glazing/sealants were missing or deteriorated. Algae and vegetation growth were observed at various locations.

Overview of Eastside Elementary School.
