- **Location:**
Three Rivers, Michigan
- **Profile:**
Manufacturing facility
- **Project:**
Multiple system roof replacement project

Armstrong International *Three Rivers Plant*

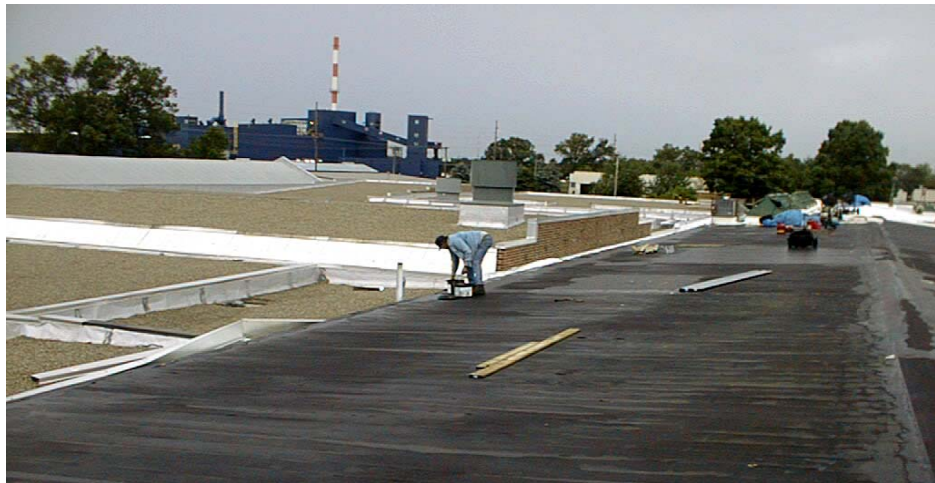
Overview of plant with work in progress.

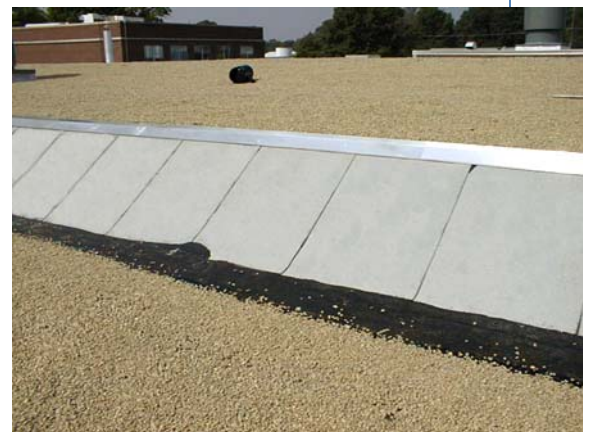
Different slopes and interconnected roof areas were challenges during the project.

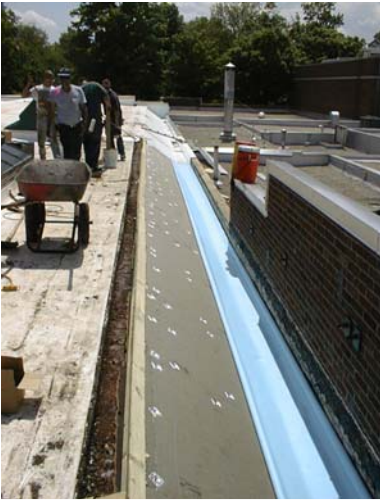
Extensive detailing ensured that all transitions were watertight.

tuminous roofing system was determined to be the best fit to tie in with the other systems. Specialty metal fabrications were specified to accommodate the copings, counterflashings, and other tie-ins at the transitions with parapet

walls. Intense detailing was implemented to tie together all of the diverse components and specialty applications. StructureTec also designed additional drains and deck replacement where necessary to prevent ponding water and ensure the structural stability of the new roof. The project was then competitively bid out. During the con-

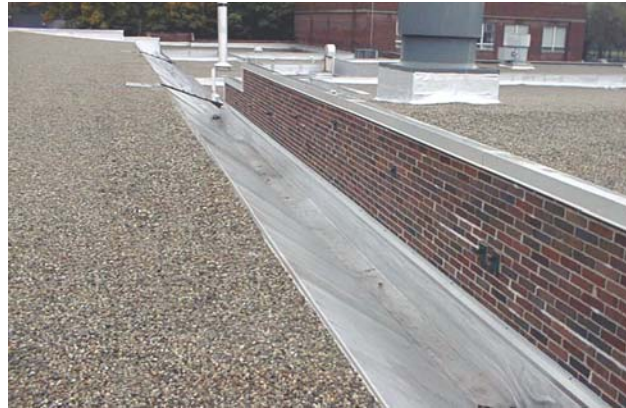
StructureTec conducted Field Quality Assurance to ensure that all the details of the project were correct.

struction phase, StructureTec conducted all necessary Field Quality Assurance to ensure that all of the details of the project were correct, ensuring the highest overall quality. In conclusion, Armstrong International had new, diverse roof systems which met the requirements of their facility. Because all applications were designed for durability and longevity, Armstrong International was assured the greatest return on investment. ■

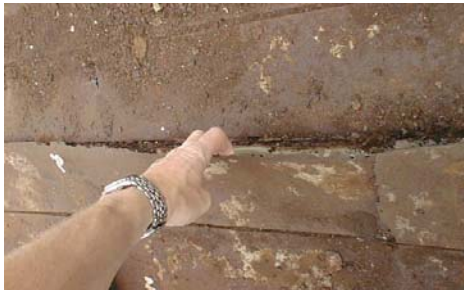
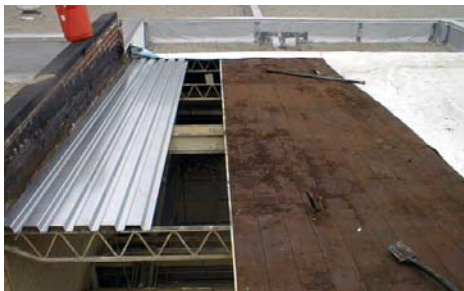
in numerous locations for an extensive amount of time. This had caused areas of the deck to become extremely degraded and require replacement. StructureTec

Because of extreme degradation,...

...portions of the deck were replaced.

Replaced existing corroded deck with new anticorrosive steel deck
