- **Location:**
Saline, MI
- **Profile:**
203, 795 sq. ft. (replaced)
- **Project:**
Roof Replacement
Single-Ply

Saline Area Schools

Saline High School

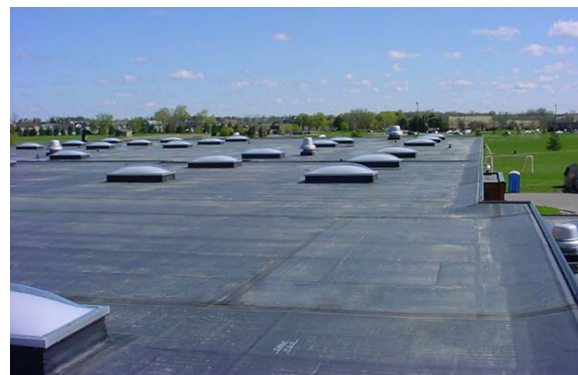
Areas of the roof included a number of skylights which required special attention and detailing.

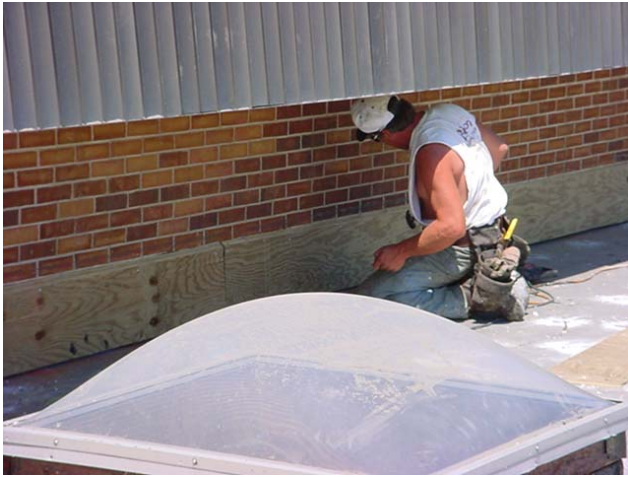
New baseboards with proper flashing were installed along the parapet wall.

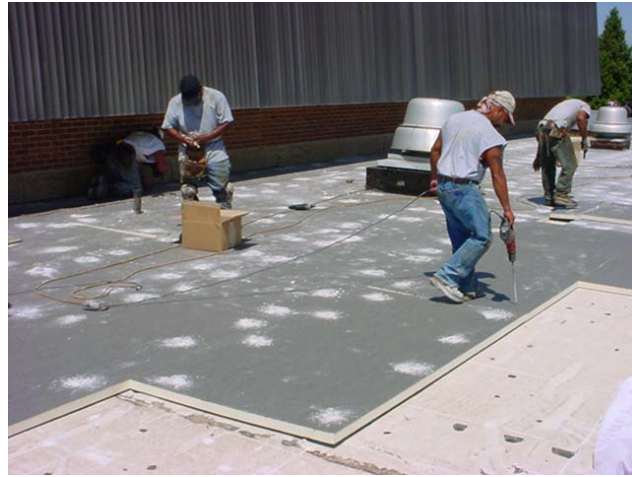
The insulation boards for the replacement roofs were mechanically attached to the deck.

tem was removed down to the structural deck. Two layers of poly-isocyanurate insulation were installed, with a tapered system around the roof drains. The reinforced, black EPDM membrane was then installed as a fully-adhered system. Special attention to detail was given to fascia systems, base flashings, counterflashings, parapets, copings, and field of the roof details. Field Quality Assurance was performed throughout this phase to ensure overall project quality. In addition, a final walkover was conducted and a formal Punch List was developed as part of the project close-out administration. By designing a fully-adhered system, the life expectancy of the

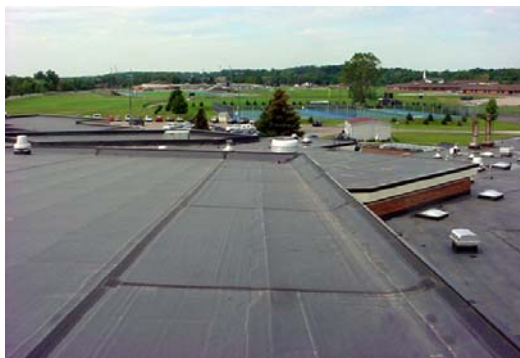
Overview of roof replacement
