- **Location:**
Grand Rapids, Michigan
- **Profile:**
Hospital Campus
- **Project:**
Building Envelope Program, Evaluation

Spectrum Health Blodgett Campus

Plaza Waterproofing / Green Technology

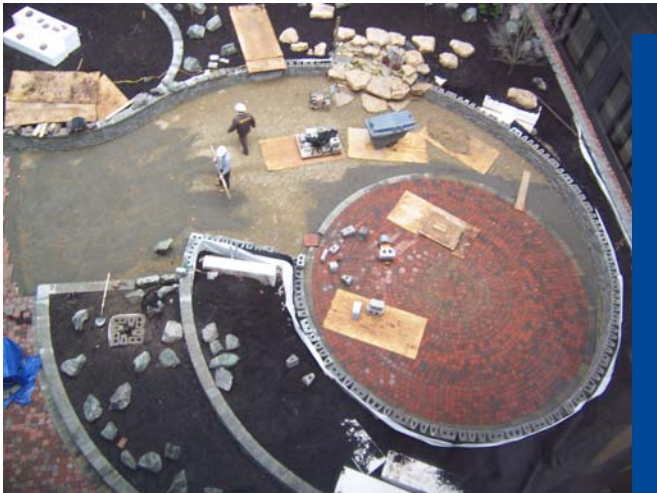
Installation of duel layer system during construction phase

By employing a duel layer system, during the

replacement of the waterproofing system, the sensitive nature of the operations below were addressed. The first layer of the system was a squeegee applied rubberized liquid that could be applied as soon as the concrete was cleaned after removal of the old BUR membrane. This initial layer also served as a primer and surface leveler for the flexible, self-adhering membrane (single-ply). The entire deck was prepared with this initial layer allowing the primary membrane to be installed in the largest/monolithic method possible.

This duel layer system minimizes the detailing required, which provides less opportunity for future leakage. In addition, no penetrations were allowed through the waterproofing system for the landscaping.

As a final quality assurance check, the entire area (75' x 75') was submerged under 2-inches of water for 24 hours. Minor repairs were required at 42 seam locations, even though no leakage was experienced below. A 2nd, 24 hour water test was then completed with no leakage.
